PIPING FAILURE IN SUBWAY CONSTRUCTION DUE TO INTERNAL EROSION OF SILTY SAND

Kenji ISHIHARA¹ and Wei F. LEE²

Key Words : Piping, Subway, Internal erosion, Silt, Pinhole test

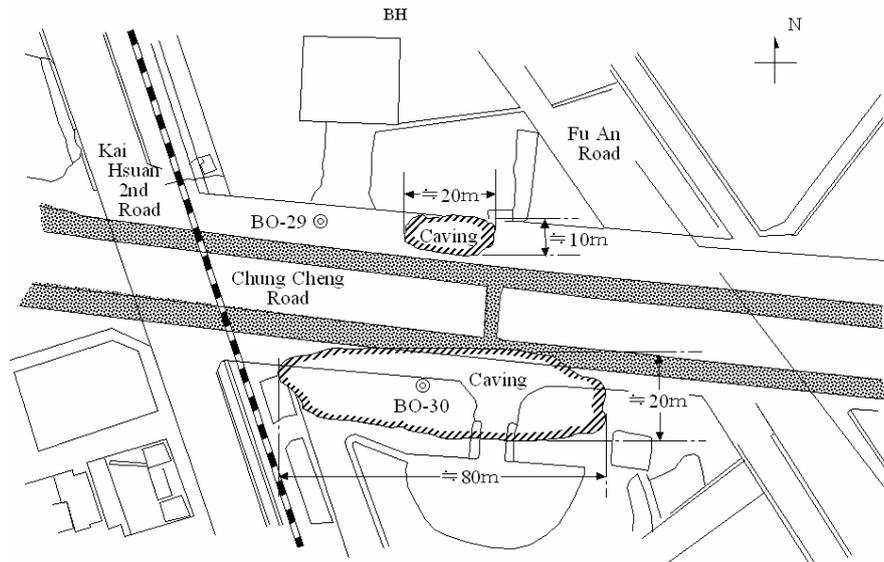
and water from the rips opened on the ceiling at the junctions between the shield segments. This breakage culminated eventually in a large scale collapse of the tunnel structure involving formation of two cave-ins on the ground surface.

Fig.1 Features of the cave-in in plan view.

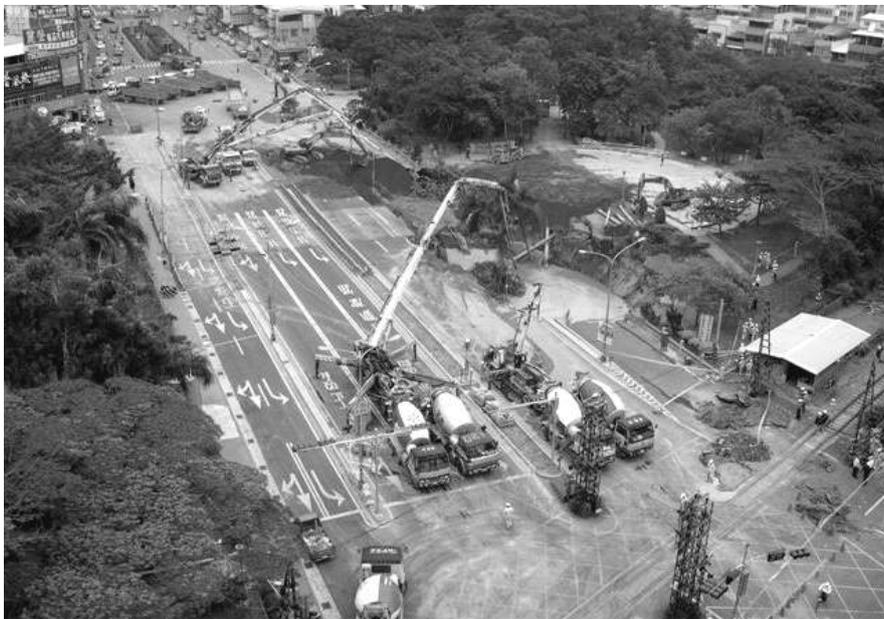
Fig.2 A bird-eye views over the cave-in in Kaohsiung.

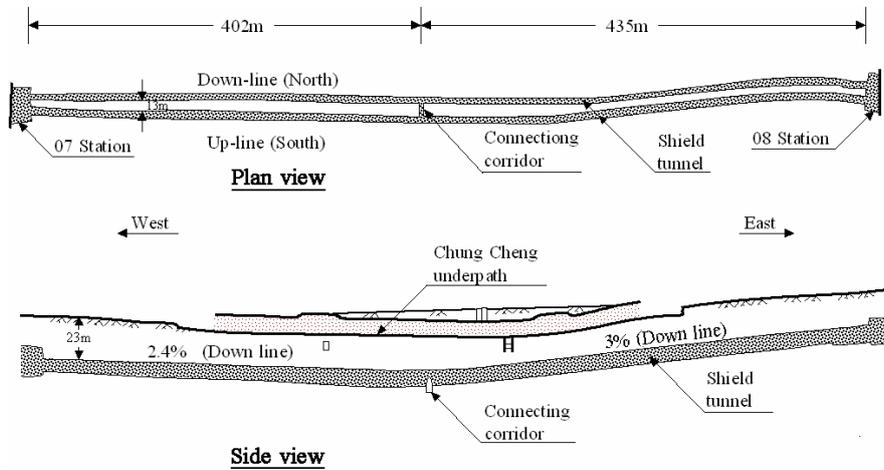
The feature of the cave-in on the ground surface is displayed in Fig. 1. A bird-eye view over the cave-in is displayed in Fig. 2. The plan and side view of the tunnel are shown in Fig. 3. It is to be noted that there was an underground roadway called Chung Cheng underpath just above the subway tunnel. The dual tunnels were constructed by the tunnel boring machine (TBM) which can advance by rotating a large steel disk equipped with cutting blade, while the cutting face is balanced by the mud pressure.

Fig.3 Plan and side view of the tunnel.

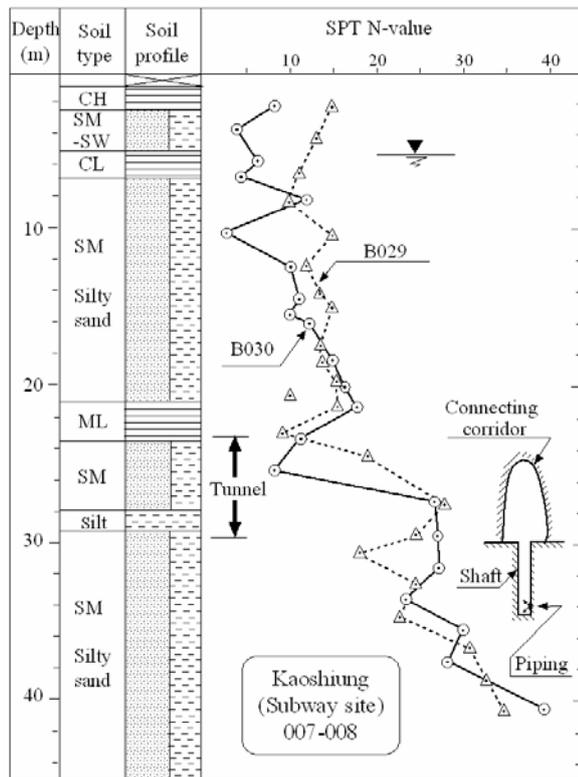
Fig.4 Soil profile at the site of collapse.

The soil profiles at the locations BO29 and BO30 in Fig. 2 are indicated in Fig. 4, where it can be seen that the deposits are comprised predominantly of silty sand with occasional layers of low-plasticity clay (CL) to a depth of 40m. The blow count, N-value, in the standard penetration test is shown to increase with depth and to have a value of 20 to 30 at the depth where the sump for water collection was excavated.

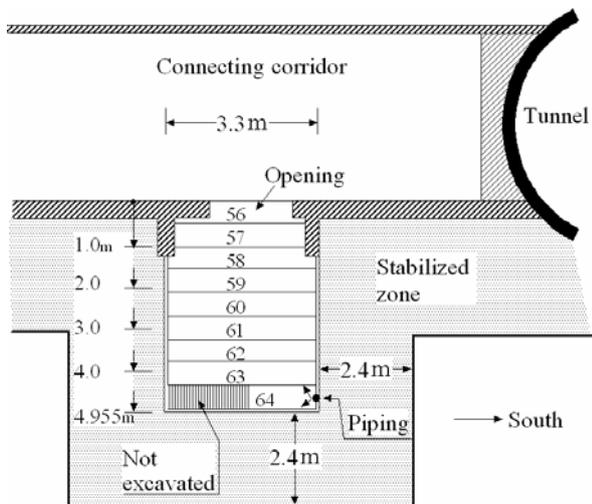
Fig.5 Details of the excavation for the sump and initiation of piping.

On December 4, 2005, the piping occurred at 3:30p.m. at the very last stage of excavation of the sump. A block of silty sand was detached from the south wall at the bottom of the excavation which is located at a depth of 35m from the ground surface. The circumstance at this time at the bottom of the sump excavation is illustrated in details in Fig. 5.

It is believed that the mud water flowed into the sump from the bottom through a single hole probably with a diameter of about 30cm. This assumption would hold true in the light of the fact that the zone stabilized by the jet grouting could not so easily broken down in the horizontal direction, and a weak zone might have existed in the vertical direction.

(3) The hydraulic pressure at the depth of 34m where the piping was initiated was estimated as being about 300kPa and the length of conceivable shortest path for seepage was 2.4m as counted from the bottom level of the stabilized zone. Thus, the hydraulic gradient at the time of the piping is estimated as having been of the order of $i=300/2.4=12.5$ which was fairly high.

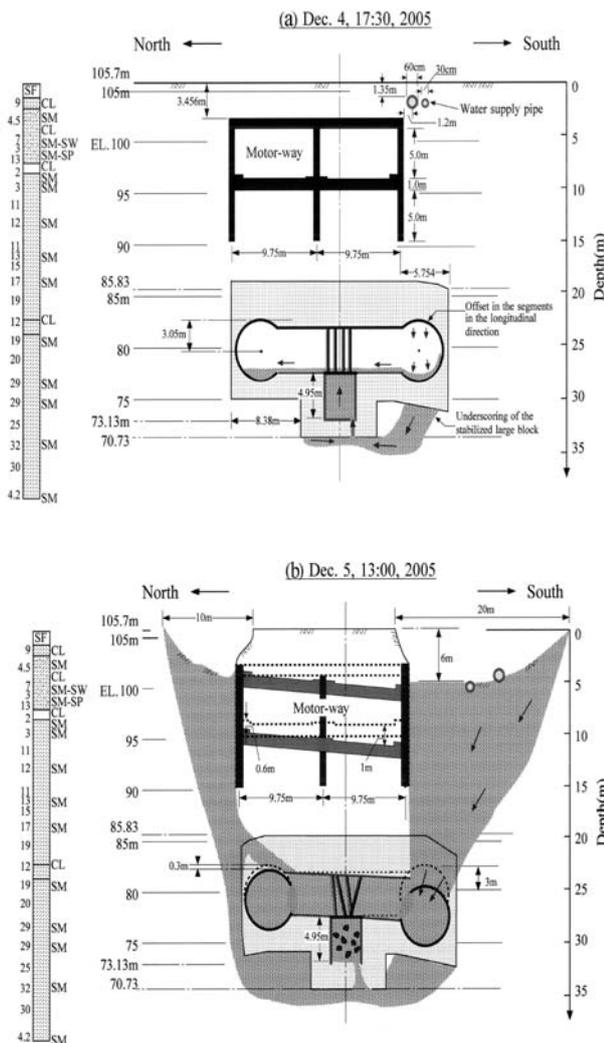
A sequence of the events after triggering the piping which are likely to have occurred is illustrated in the cross sections in Fig. 6. The blackish mud water continued to come out in the sump with increasing volume. Two men at work at the bottom strove in vein to clog the hole by dumping sand bags from the corridor. About two hours later, the workmen closed the entrance to the sump by placing a steel lid and several bars for its support (Fig. 6(a)).

About a few hours after the initial collapse, engineers at spot heard squeaking sounds of breaks at segment joints of the tunnel on the south, accompanied by mud water cascading from the ripped joints of segments at the ceiling. It appears likely that because of the underscoring of the bottom portion, the stabilized zone subsided together with the tunnel body, resulting in the stepwise settlement in the longitudinal directions illustrated in Fig. 6(a).

Around 10:20p.m., the fall-off of the soil above the ceiling had spread upwards and, assisted by the slipping along the vertical wall of the motorway structure, soil mass fell down into the tunnel. This resulted in creation of a large cave-in on the ground surface on the south side as illustrated in Fig. 6(b). At this time, two mains 60cm and 30cm in diameter for water supply were broken releasing a large amount of water for a prolonged time. This breakage of the buried pipes appears to have transferred the collapsed soil deposits into more flowable debris.

Fig.6 A sequence of likely scenario for progressing the piping failure.

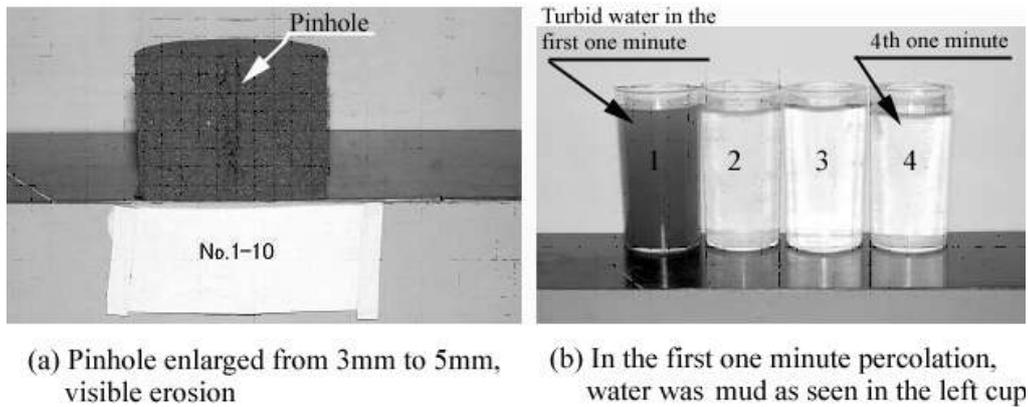
Fig.10 Silty-contained sample from Kaohsiung.

In the first series, the tests were conducted on disturbed samples, one from Kaohsiung and another from Japan. The result of the pinhole tests on a disturbed sample is presented in Fig. 10. For the disturbed silt-containing sand sample from Kaohsiung, the pinhole is seen enlarging to a diameter of 5mm from 3mm as displayed in Fig. 10(a). Correspondingly, the drained water from the bottom was muddy for the first one-minute period of water percolation as seen in the water colour in the left-side cup of Fig. 10(b). The result of the pinhole test on the Japanese silty sand is shown in Fig. 11. In contrast to the Kaohsiung soil, the circulation of water through the Japanese soil did not exhibit any appreciable change in colour in the first one minute of percolation as seen in Fig. 11(b).

There was no change in the pinhole diameter for the Japanese soil before and after water permeation except for a local collapse at the top. Thus, it may be conclusively mentioned that the silty sand from Kaohsiung is potentially susceptible to internal erosion as compared to the soil from Chiba, Japan, although they had almost the same grading.

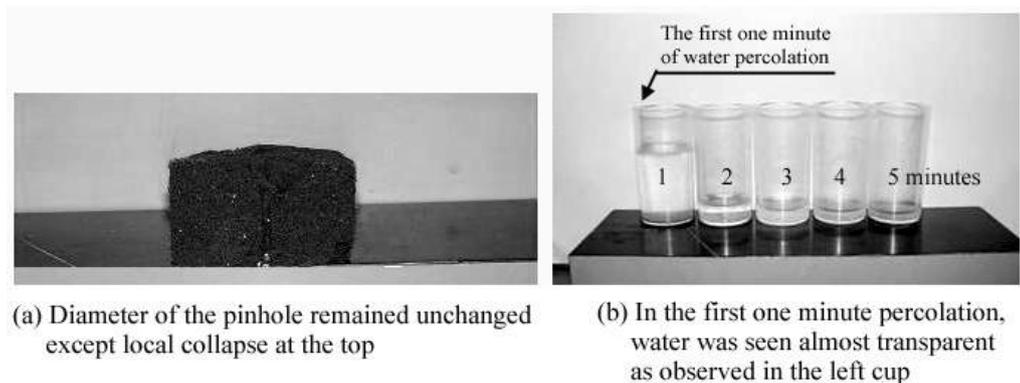
Fig.11 The results of the pinhole test on the Japanese silty sand.
