Collapse Scene Investigation (CSI) Carmel River Bridge Failure

Catherine M.C. Avila, P.E., D.WRE, MSCE, MBA

Key Words : Carmel River, Bridge Scour Failure, Detour Cost, Temporary Bridges

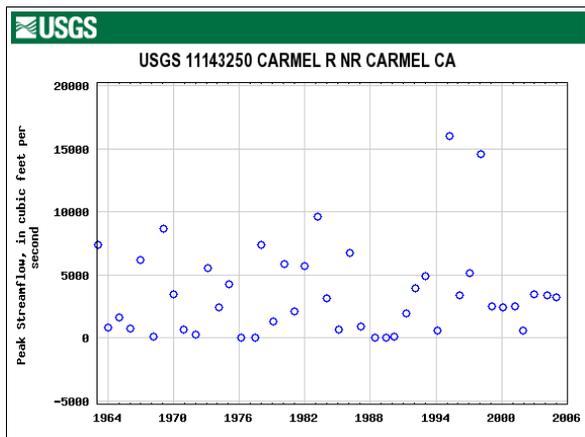
Figure 4: Discharges at the Carmel River Gage near Carmel (note discharges in cubic feet per second)

The gage upstream of the bridge (Carmel River near Carmel, Gage #11143250) has been in place since 1964. The highest recorded discharge was 453 cubic meters per second (cms) on March 10, 1995 when the bridge failed as shown in Figure 4.

The FEMA study estimated the 50-year discharge to be 651 cms and 100-year discharge to be 824 cms (FEMA, 1991). The March 10, 1995 discharge of 453

cms equates to approximately a 30-year discharge assuming the above hydrology is valid. The proposed pedestrian and bicycle bridge over the Carmel River provides an excellent opportunity to see if the forensic clues that led to the March 10, 1995 Carmel River bridge failure can be used to enhance the longevity and survivability of the new bridge under a variety of flood events.

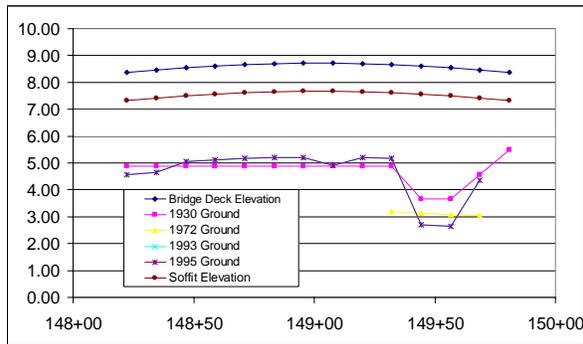
Figure 5: Ground Elevations and Profile of the 1934 Bridge (meters)

The bridge which was designed was made longer (158.5 m instead of the proposed 146.3 m) than the preliminary recommendations. In addition, a vertical curve with a maximum soffit elevation of 7.9 m and minimum soffit elevation of 7.6 m was added provided as shown in Figure 5.

A cross section was taken on March 2, 1995, just 8 days before the bridge failed. According to the cross section information (see Figure 5), the river degraded approximately 1-meter between 1931 and 1995. The degradation decreased the pile embedment from its original 5 m at Pier 12 and 5.4 m at Pier 11 to 4 m at Pier 12 and 4.4 m at Pier 11. The original estimated pile penetration was 5.5 m according to the 1931 Preliminary Investigations Report (State of California, 1931), which is greater than the actual penetration achieved in construction.

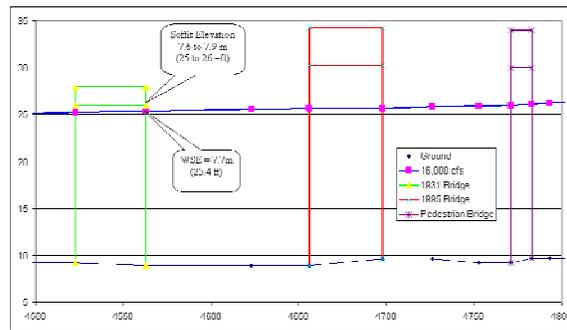
Figure 6: Output from HEC-RAS Hydraulic Model

A hydraulic model (HEC-RAS) set up by Balance Hydrologics, Inc. was utilized to estimate the hydraulics at the bridge as it was in 1995. Although the model utilizes the 2007 topography, if the record discharge of 453 cms is contained in the channel, it provides an estimate of the water surface elevation and velocity for the old Highway 1 Bridge as shown in Figure 6.

Debris pummeling the bridge was caught on amateur video late Friday afternoon just hours before the bridge collapsed by a local resident who commented that it “felt like an earthquake.” The documented debris included debris rafts and large trees, which were over 30.5 m long with 1.8 m diameter root-balls. The water was at or near the soffit of the bridge with significant debris catching on the piers. Debris lodged on a pier can increase local scour at the pier by increasing the pier width and deflecting a component of flow downward. HEC-18 recommends estimating the scour depth by assuming the pier width is larger than the actual pier width and notes the problem is determining the increase in pier width to use in the pier scour equation. According to HEC-18, limited studies of pressure flow scour indicate that pier scour can increase 200 to 300% for a bridge under pressure flow (Richardson et. al., 2001).

With relatively small piers (0.46 m), the pier scour is 1.1 m. This leaves 3 to 3.3 m of pile embedment. If the pier width is assumed to double due to debris, the pile embedment is decreased to 1.8 to 2.1 m. Likewise, if the pier scour depth is doubled or tripled, the pile embedment is dramatically decreased.

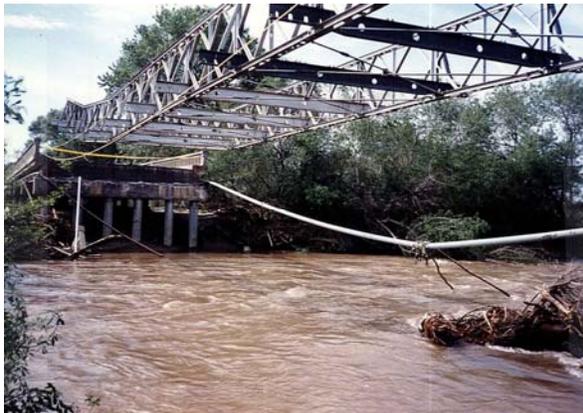
Figure 7: Looking downstream at Bailey Bridge Launching in March, 1995 (photo by Steve Ng, Caltrans)

In order to open the route to traffic as quickly as possible, a Bailey bridge which was stored at the Caltrans Maintenance yard at the San Francisco Oakland Bay Bridge was trucked down from Oakland to Carmel. The turnaround was fast: the 1934 bridge failed late Friday March 10th. The Bailey bridge was “designed” and loaded on trucks on Saturday, March 11th. The new bridge erection started on Sunday and was completed Thursday, March 16th (see Figure 7).

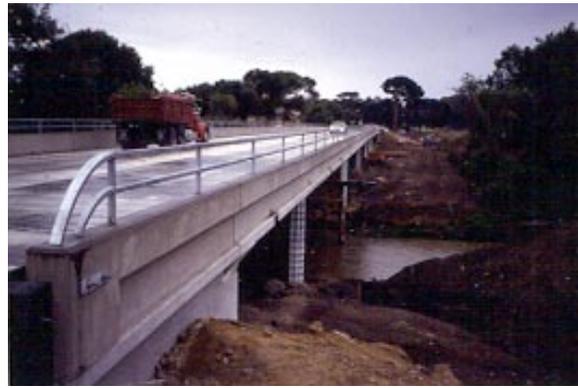
Figure 8: New Highway 1 Bridge with Pier Wall Construction under way (photo by Author, 1995)

The new bridge was designed while the Bailey bridge was under construction. The recommendations were 0.9 m of freeboard over the estimated water surface elevation during the 1995 storms with 30.5 m spans. Work started on the permanent bridge on April 1, 1995. It was opened to traffic on May 5, 1995 and was completed by September 1995 (the training walls were installed after traffic), as shown in Figure 8. The bridge cost almost \$3.5 million U.S. dollars (Caltrans, September 1995).
