**Studies on Alternative Technical-
Biological Bank Protection Measures
Applied on Inland Waterways**

Part 2:

**Test Stretch Stolzenau / Weser
Km 241.550 – 242.300**

**R & D Project
(BAW - BfG)**

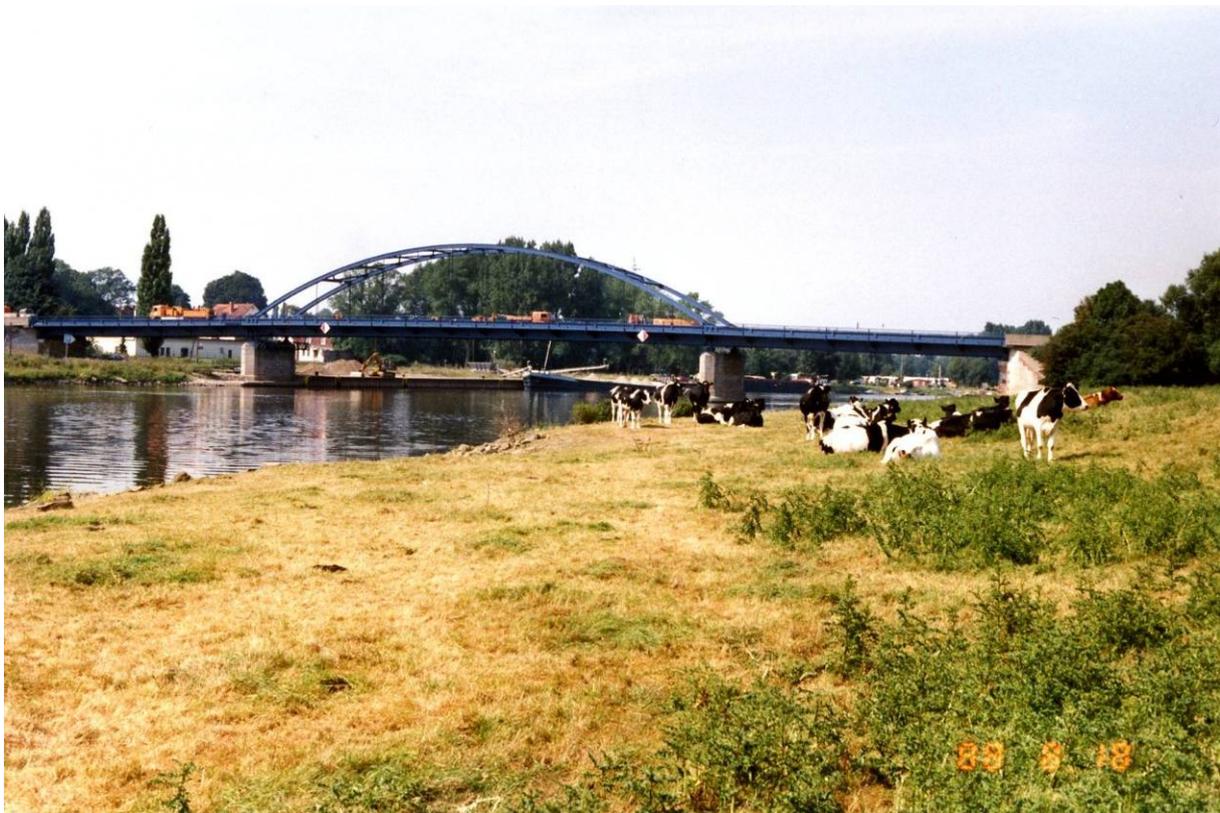
In the upstream section, which is about 300 m long, the bank was divided up by single groyne, and in the downstream section, it was developed with a relatively uniform slope protected by armour stones. The adjoining terrain was used as grazing land (Figure 4.1).

Figure 4.1: Initial condition of the test stretch: used right up to the banks for grazing (18/08/1988)

Neither mapping material nor an assessment of the initial situation before installation of the test stretch was available; only a brief description exists. According to this, the area of the test stretch was grazed right to the banks (cf. Chapter 4.1 and Figure 4.1, page 7) and along the bank there were small groups of bushes, isolated colonies of reed canary grass and some tall forbs.

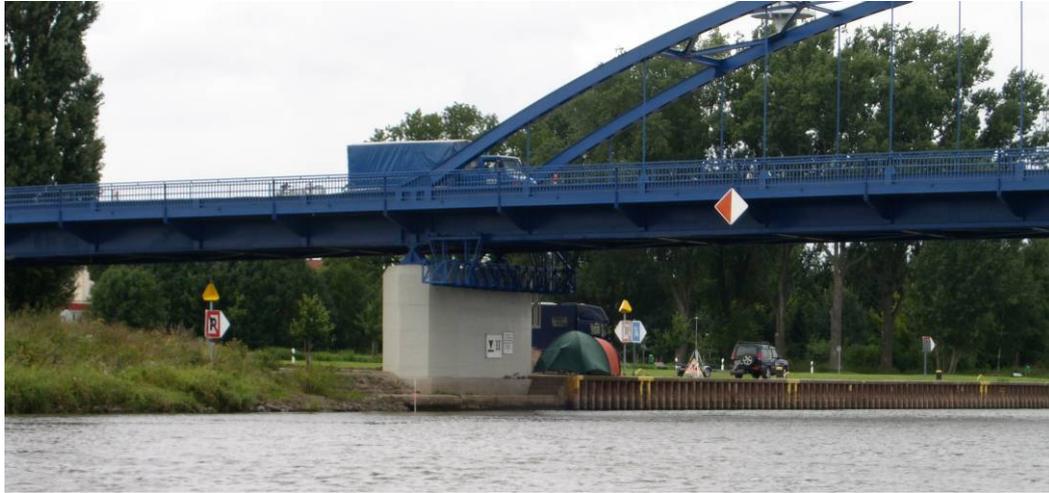
Figure 6.8: View of the hidden measuring equipment north of the road bridge on the left bank

A high-resolution radar system which was set up in a tent, hidden from view, was used to measure the speed of ships and the distance from the bank (cf. Figures 6.8 to 6.10). Figure 6.11 provides an impression of the radar screen during passage of a cargo vessel.

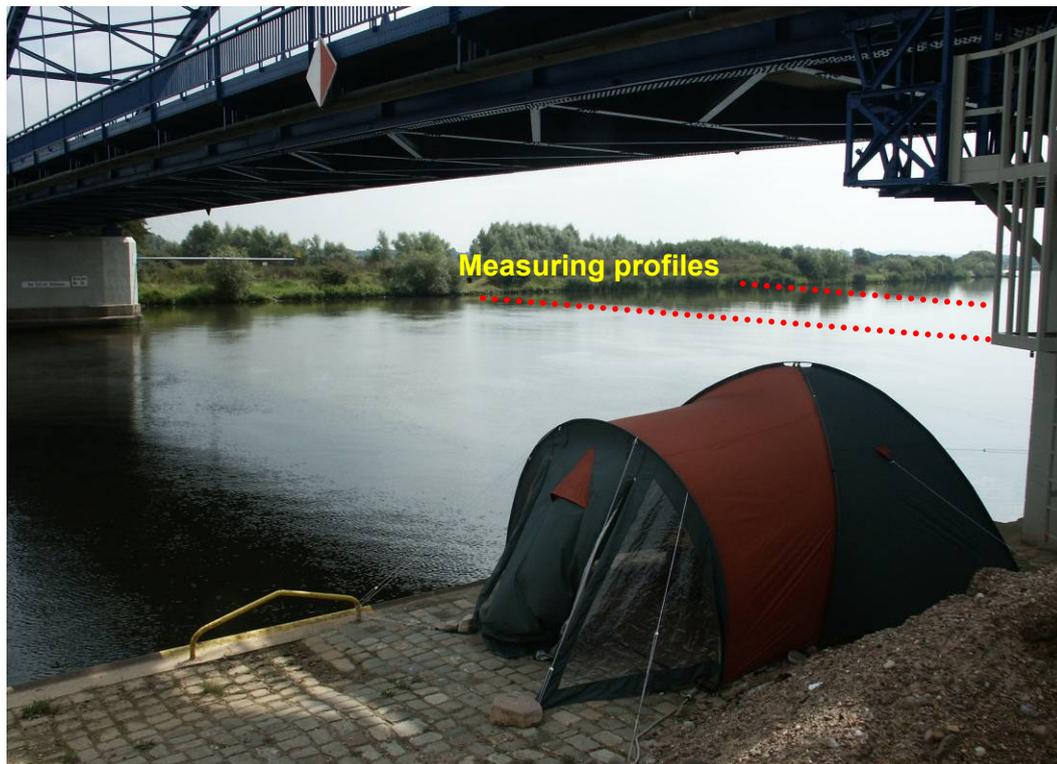
Figure 6.9: View of the measuring profiles (dotted lines) from the measuring tent and the test stretch on the opposite right bank

For the sounding of the two measuring profiles (approximate position, cf. dotted lines in Figure 6.9) with a sonic depth finder, the accompanying measuring boat (L/B/D = 5.1 m / 1.86 m / 24 cm) was also used. Furthermore, before the start of the measurement campaign, several extra passages were made with this boat for the subsequent rectification of the radar images.

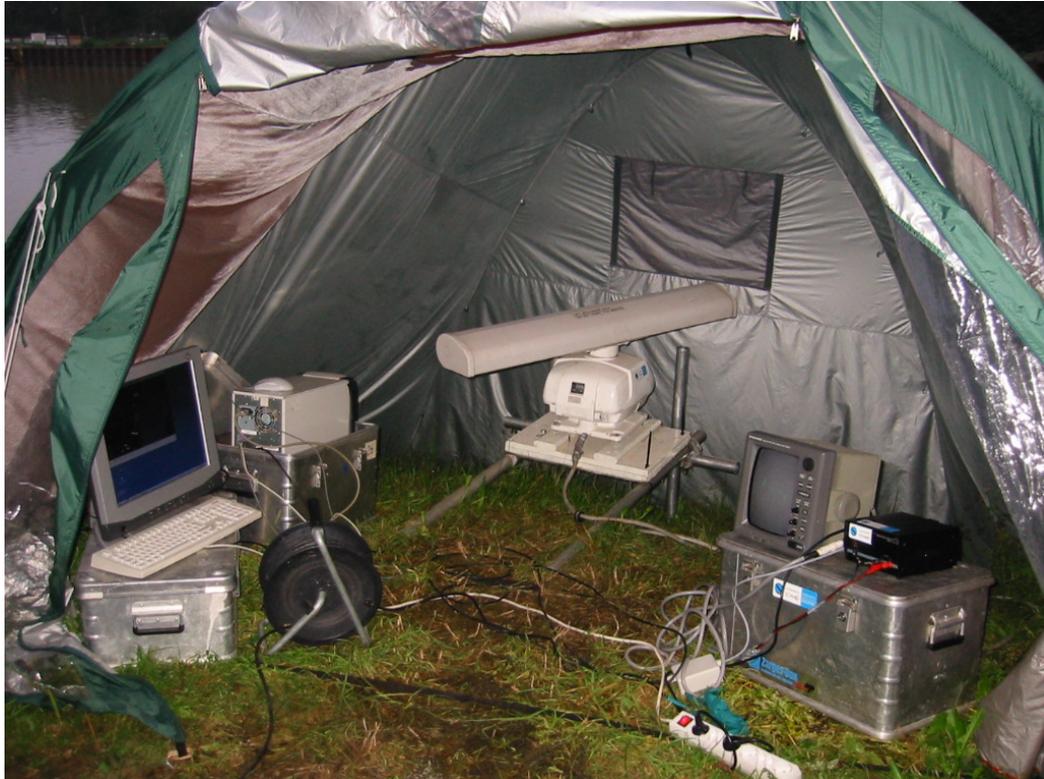
Figure 6.10: View of the radar equipment in the measuring tent

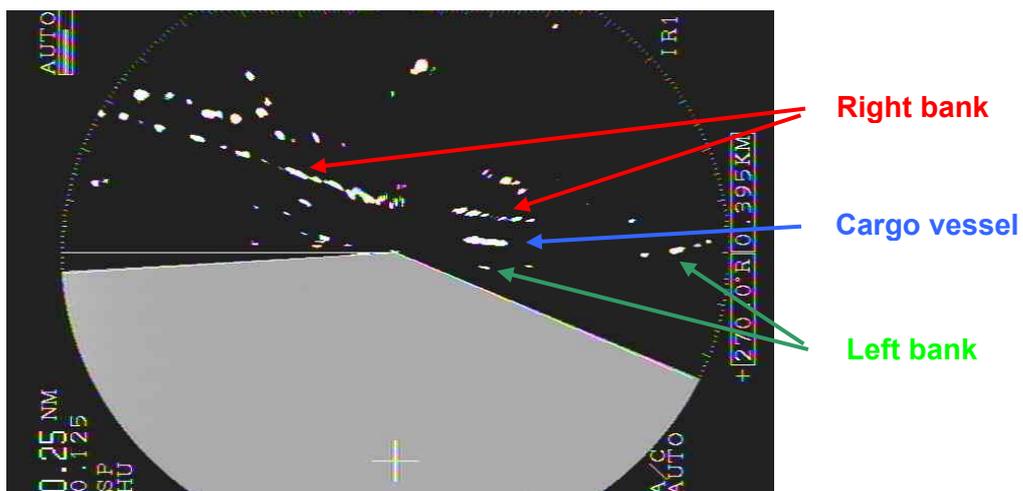
Figure 6.11: Photograph of the radar screen showing a cargo vessel travelling downstream

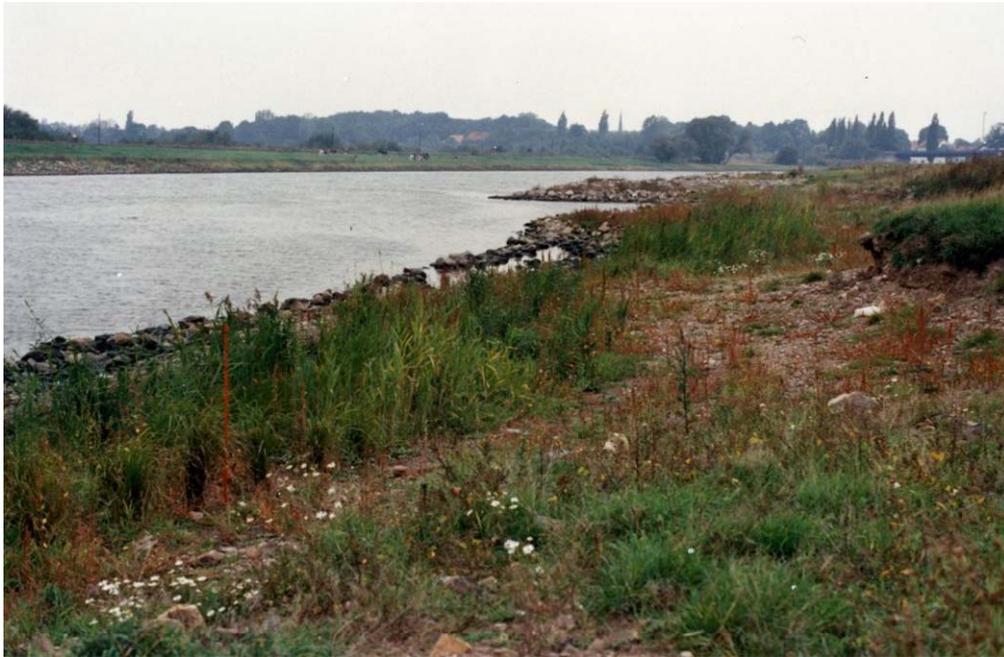
Figure 9.1: Common reed and sedge planting at the flattened bank slope: Streamwards, the rock fill of the stone mound close to the bank is visible (Sections 1 and 2; Sept. 1989; for locations of the photographs in Chapter 9, cf. Appendix 9.3)

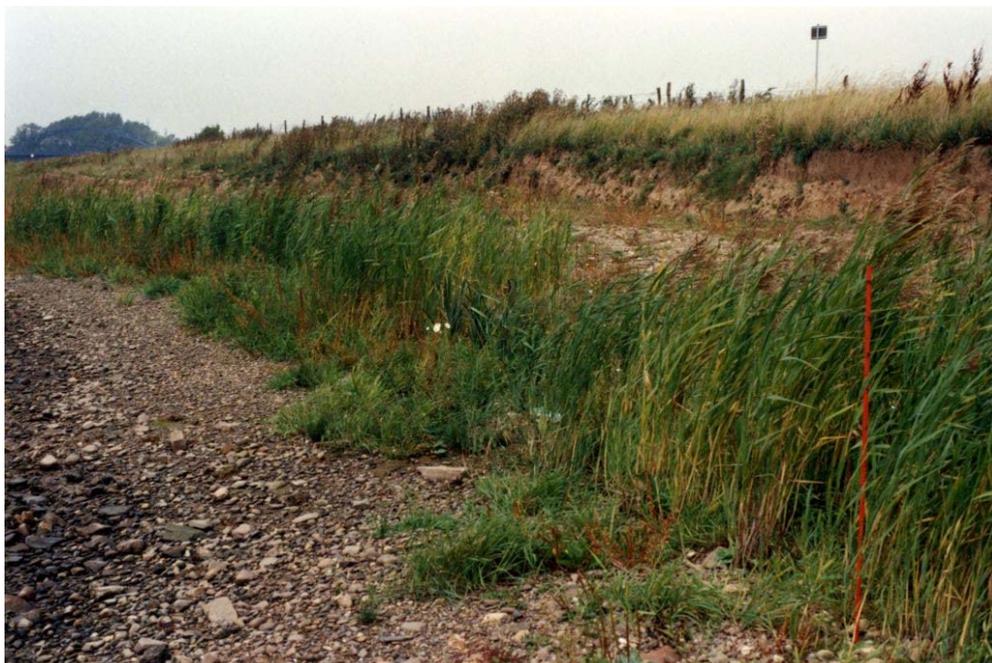
Figure 9.2: Planting of reed beds on the flattened bank slope; view from the bank to the cliff line (Section 2; Sept. 1989; the red metre stick protrudes 1 m above ground)

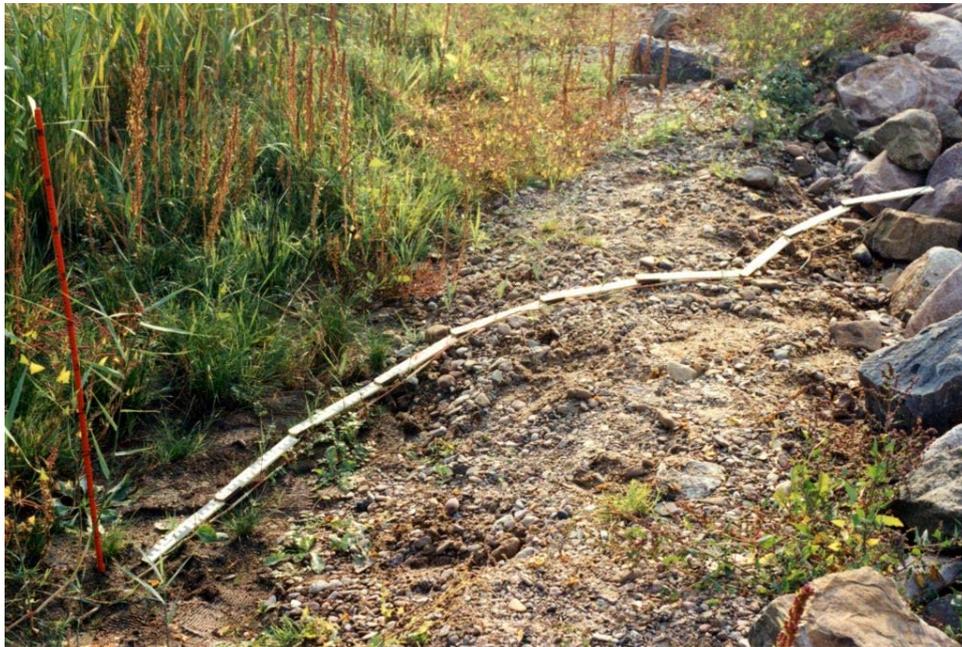
Figure 9.3: With runners sometimes more than 3 m in length (a light-coloured runner on the surface can be seen here next to the white metre stick), the common reed (*Phragmites australis*) that was planted in the spring are spreading out towards the river (Section 5, shallow water zone and island/training structure; Sept. 1989)

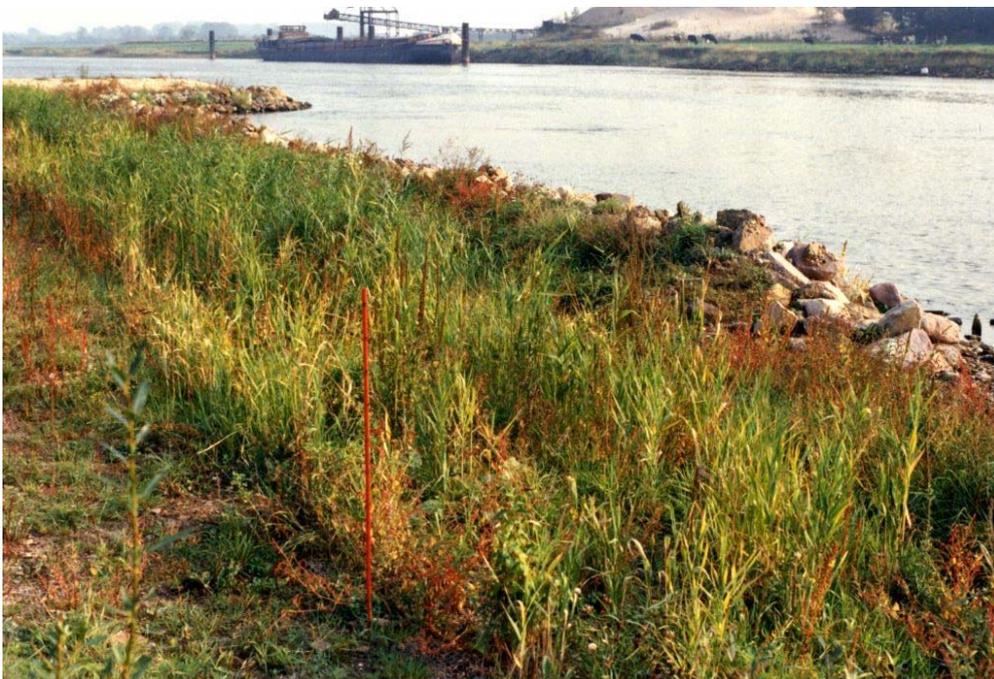
Figure 9.4: Reed bed planting on the flattened slope with a stone mound. In the background: loading facility of the gravel works on the opposite bank (Section 7; Sept. 1989)

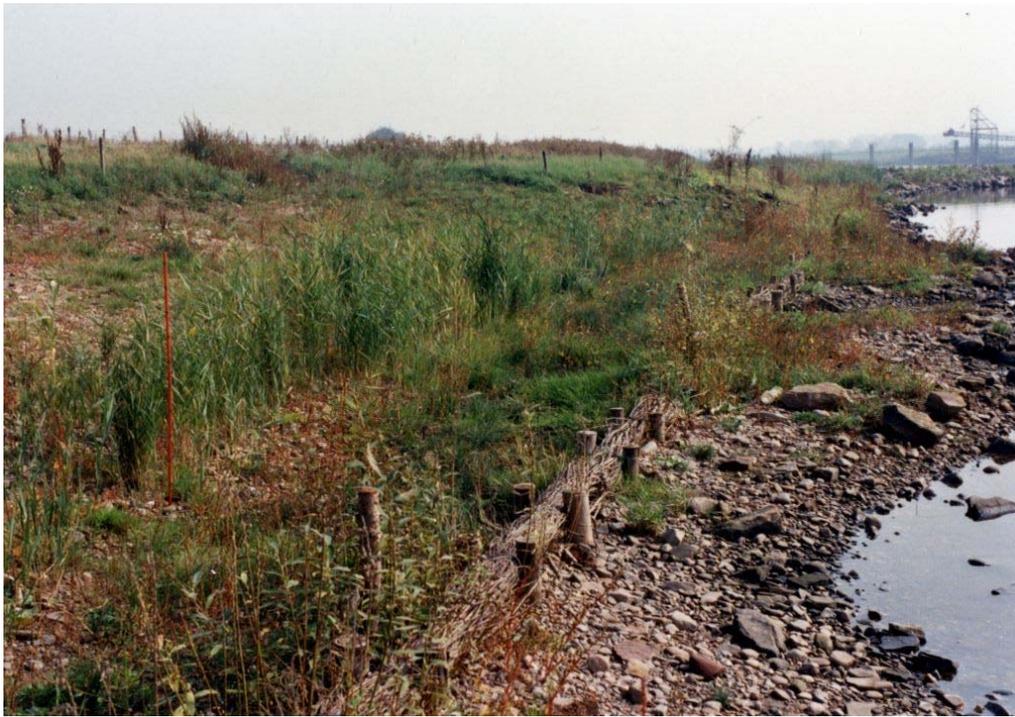
Figure 9.5: Reed bed planting on the flattened slope with protection from a willow fascine (Section 9; Sept. 1989)

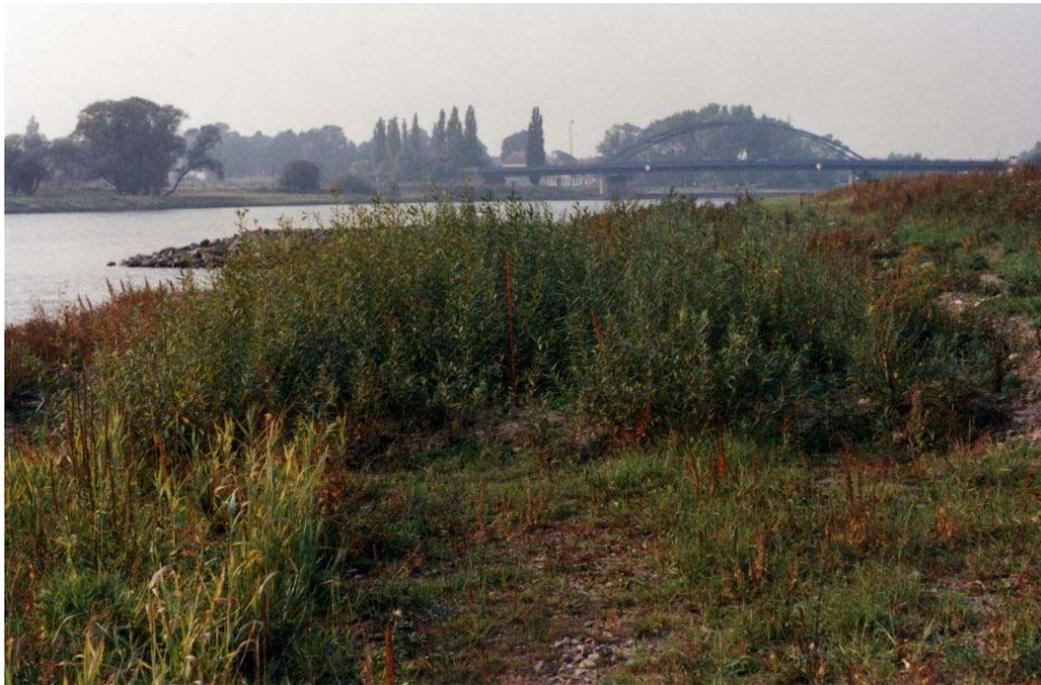
Figure 9.6: The newly installed willow brush mattresses have sprouted vigorously. In the background: the road bridge between Stolzenau and Leese (Section 7a; Sept.1989)

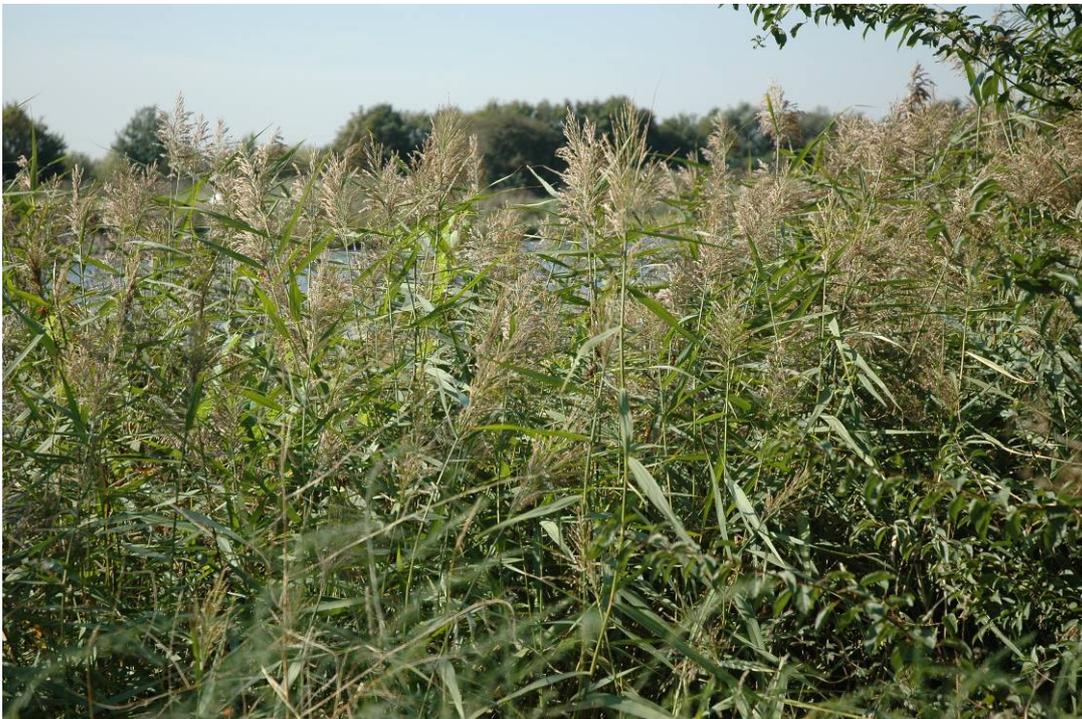
Figure 9.10: **Vegetation type (1) reed beds of common reed** (*Phragmites australis*) in the area of vegetation (photographic) record No. 1 (14.09.2006); cf. Table 9.1)

The four dominant herbaceous vegetation types were substantiated with photographs of the vegetation (cf. Table 9.1). **Vegetation type (1) reed bed of common reed** (*Phragmites australis* (Gams 1927) Schmale 1939) (Figure 9.10) has become well established in the test stretch and has spread in the vicinity of the banks (cf. also Figure 9.22, page 89).

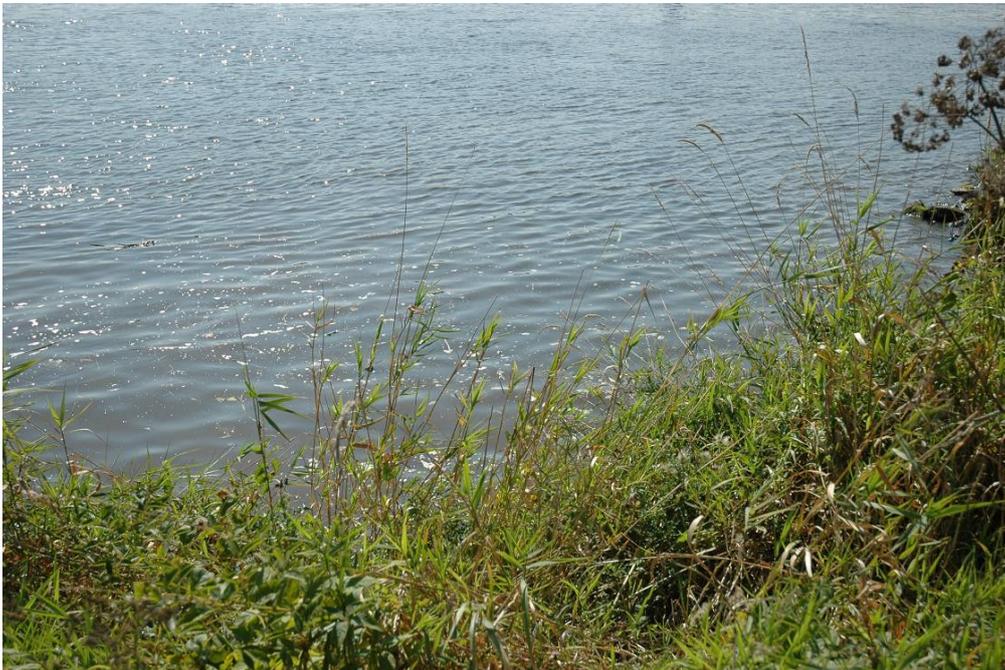
Figure 9.11: **Vegetation type (2):** Stand of reed canary grass (*Phalaris arundinacea*) rich in tall forbs with garden angelica (*Angelica archangelica*) in the area of the vegetation photograph no. 2 (14.09.2006; cf. Table 9.1)

In unplanned areas close to the bank, the dominant vegetation type is **Vegetation type (2), reed canary grass** (*Phalaris arundinacea*) **reed beds** (*Phalaridetum arundinaceae* Libb. 1931) (Figure 9.11). To the landward side, adjoining the reed bed belt, as **Vegetation type (3)** there is a **quack grass-flood meadow** dominated by quack grass (*Elymus repens*) and turniproot chervil (*Chaerophyllum bulbosum*) (Figure 9.12). Quack grass is a root creeping pioneer, a nitrogen indicator with deep roots that can withstand flooding and, like turniproot chervil, is frequently found on clay soils. The species of chervil is generally fairly rare, but is frequently found in drift line communities on riverbanks.

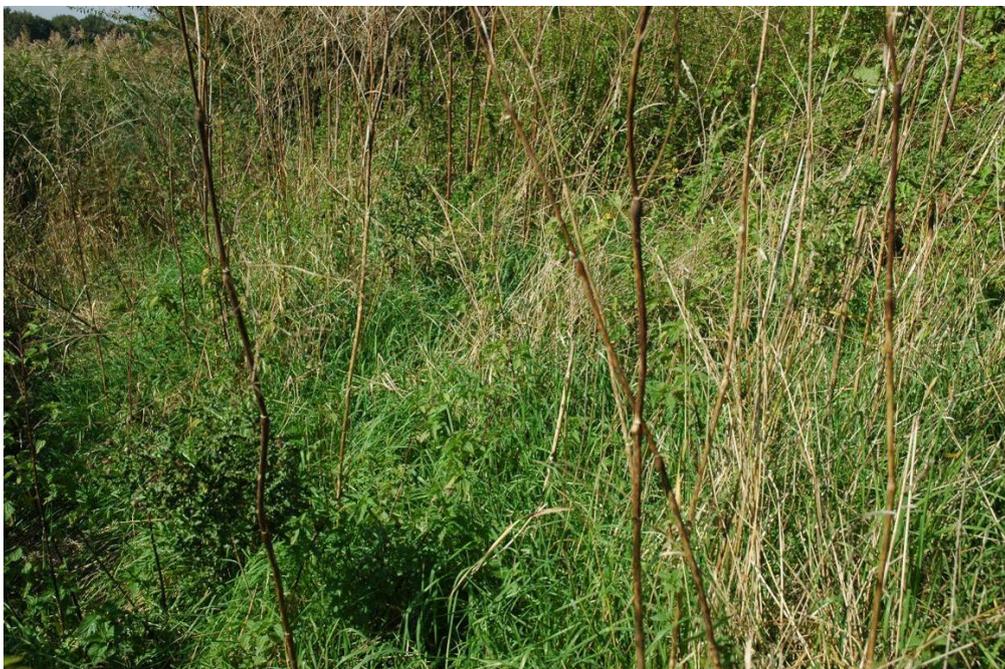
Figure 9.12: **Vegetation type (3) quack grass flood meadow,** dominated by quack grass (*Elymus repens*) and turniproot chervil (*Chaerophyllum bulbosum*) in the area of vegetation photograph no. 3 (14.09.2006; cf. Table 9.1)

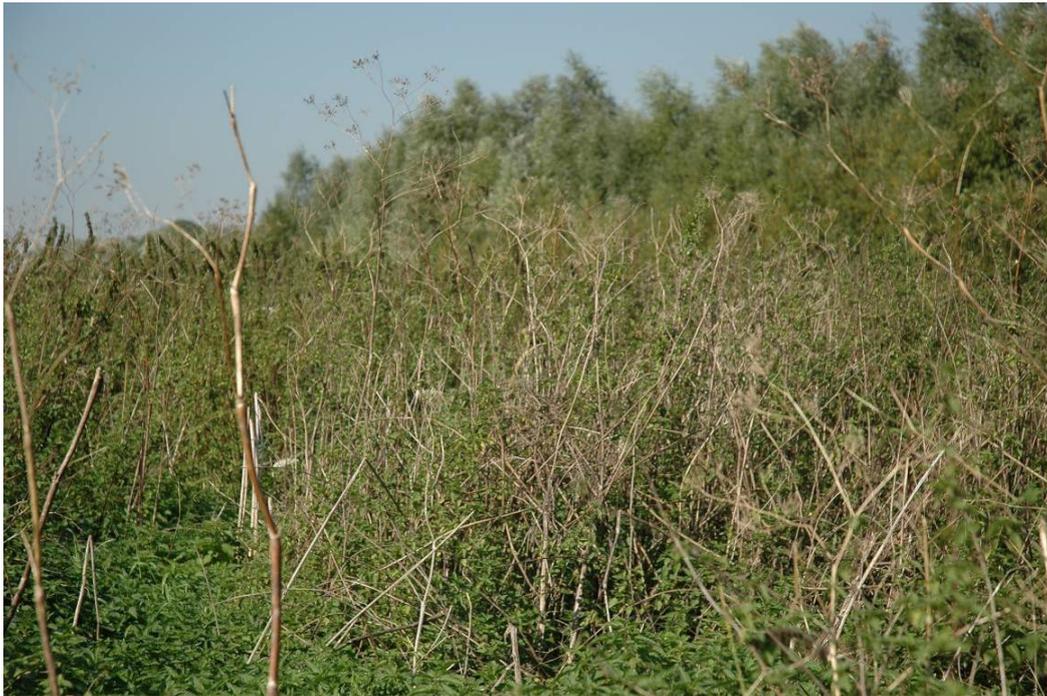
Figure 9.13: **Vegetation type (4) herbaceous riparian plants** as fallow ground vegetation, dominated by stinging nettle (*Urtica dioica*) and turniproot chervil (*Chaerophyllum bulbosum*) in the area of vegetation photograph no. 4 (14.09.2006; cf. Table 9.1)

In the part of the test stretch far from the bank, which was not restructured and which, like the entire area of the study, was excluded from the use as grazing land in 1989 by the erection of fencing, the **Vegetation type (4), herbaceous riparian plants** developed as fallow ground vegetation dominated by stinging nettle (*Urtica dioica*), turniproot chervil (*Chaerophyllum bulbosum*) and false baby's breath (*Galium mollugo agg.*), all of them species which require nutrient-rich soils, (Figure 9.13).

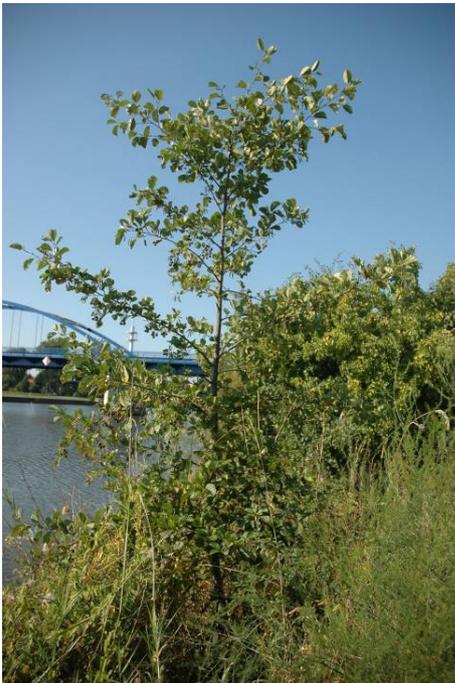
Figure 9.14: Black alder (*Alnus glutinosa*) with symptoms of *Phytophthora* infestation (alder disease): left: with irregular crown and strong fruit setting; right: so-called tarspots at the base of the stem. In 2006, 5 of 6 alder trees in the test stretch showed these symptoms (Alder 1, Section 14a, 13.09.2006)

Of the eight 1.20 to 6 m high black alders, five are diseased and two have died (Figure 9.14 - 9-16). The diseased specimens showed symptoms of the lethal alder disease (*Phytophthora*-infestation, alder root collar rot), a disease that was discovered for the first time in Germany in 1995 and which is now widespread in almost all the German federal states /BBA 2003/. The symptoms seen here include tarry spots at the base of the stem and orange-red discolouration below the bark. The only tree that appears to be still healthy is a young specimen (1.20 m tall).

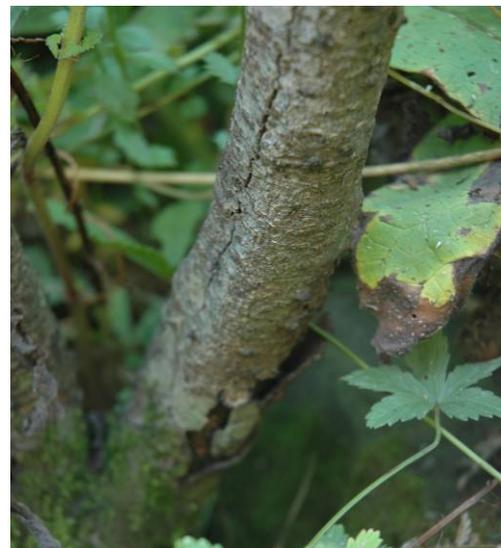
Figure 9.15: The planting stakes of the alder planted in Section 14a were still there in 2006. Centre of photo: The only surviving, but diseased, alder tree (see above; 13.09.2006)

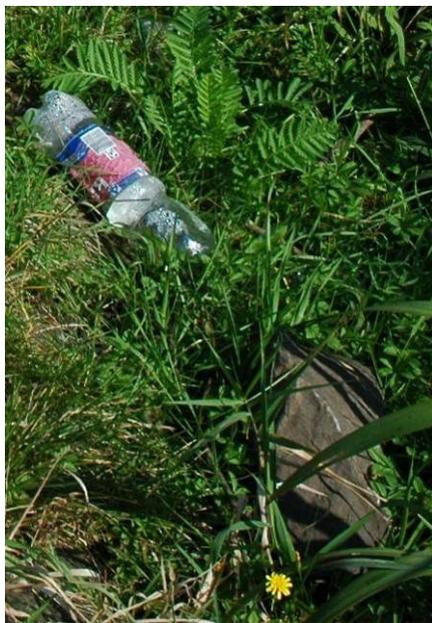
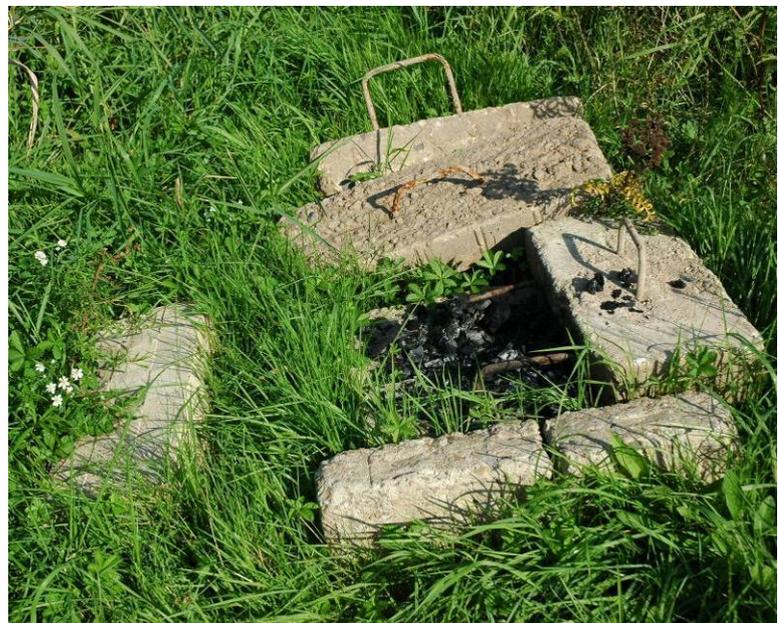
Figure 9.17: Beaten tracks, waste material (mainly bottles, but also items such as a nylon cord) and the remains of bonfire area (on groyne 3) prove that the test stretch is accessed and probably used by anglers (14.09.2006)

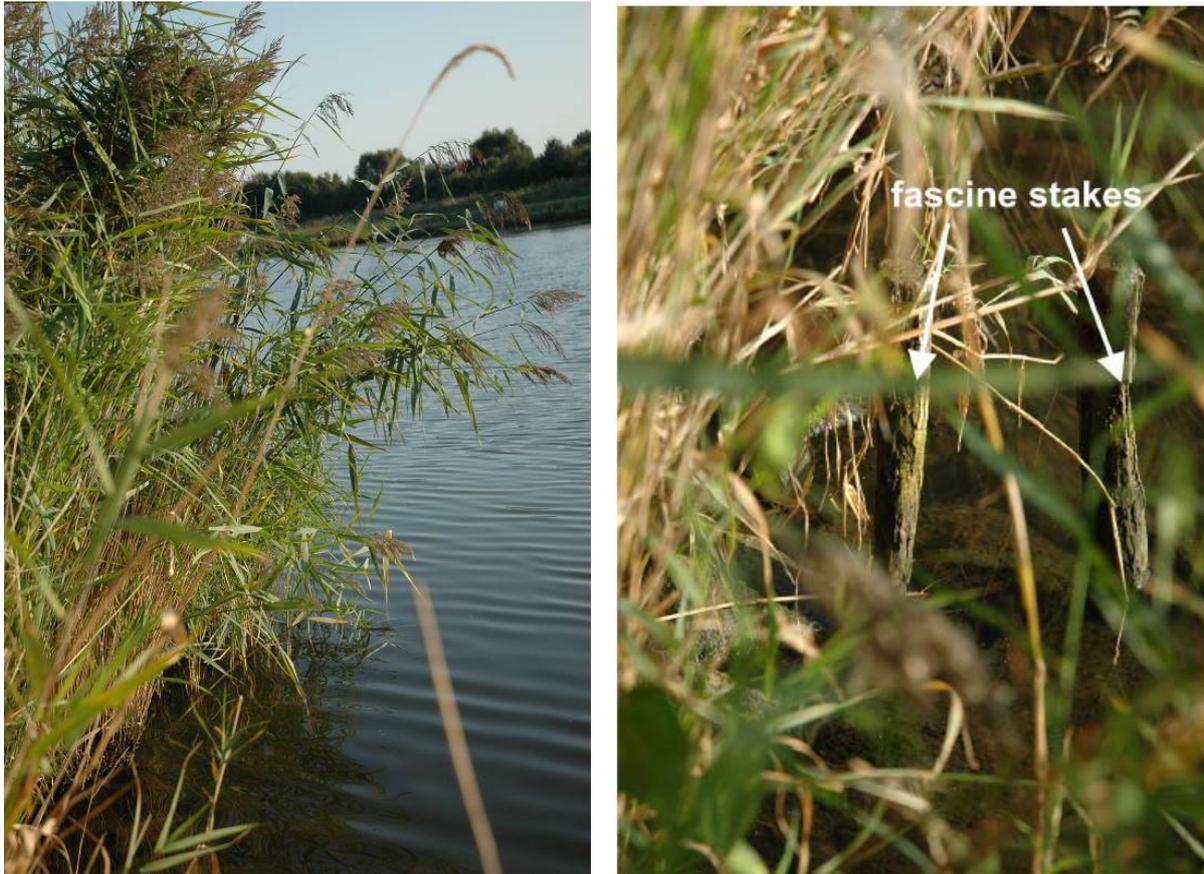
Figure 9.22: The reed bed of common reed in Section 13 has spread out on the riverward side beyond the level of the fascine that was built here in 1989 (photo, left). In the photograph on the right, the stakes for the fascine can still be seen (13.09.2006)

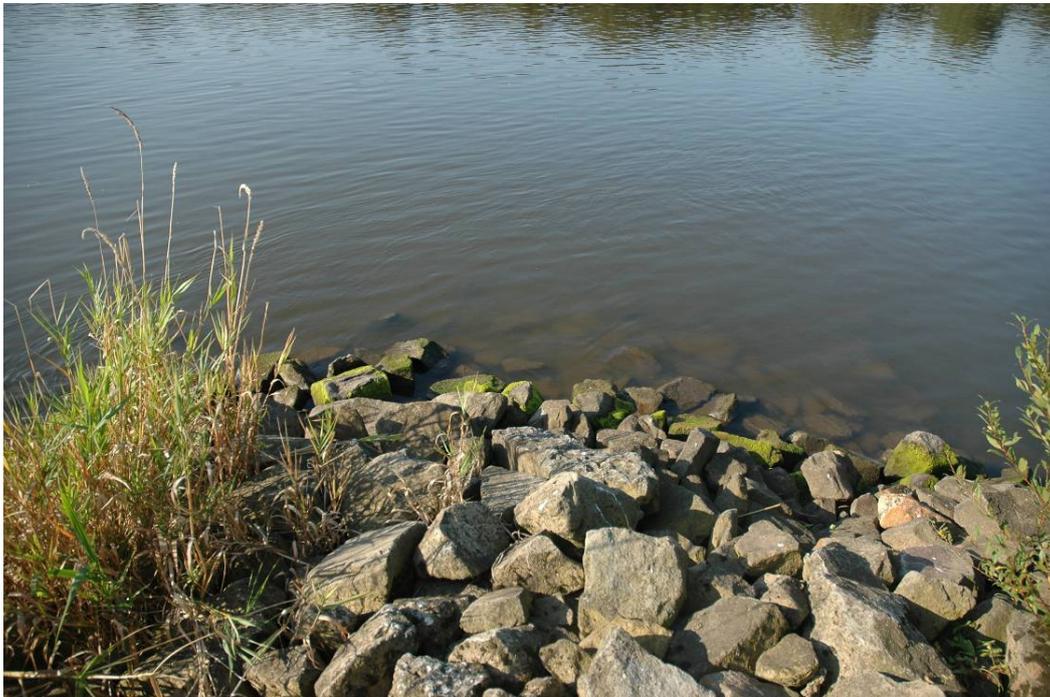
Figure 9.27: The reed canary grass (*Phalaris arundinacea*) at the left-hand edge of the photograph, and the almond willow (*Salix triandra*) at the right-hand side, showed a relatively high degree of tolerance to wave action at exposed locations (such as here at groyne head 5) (14.9.2006, at low water)

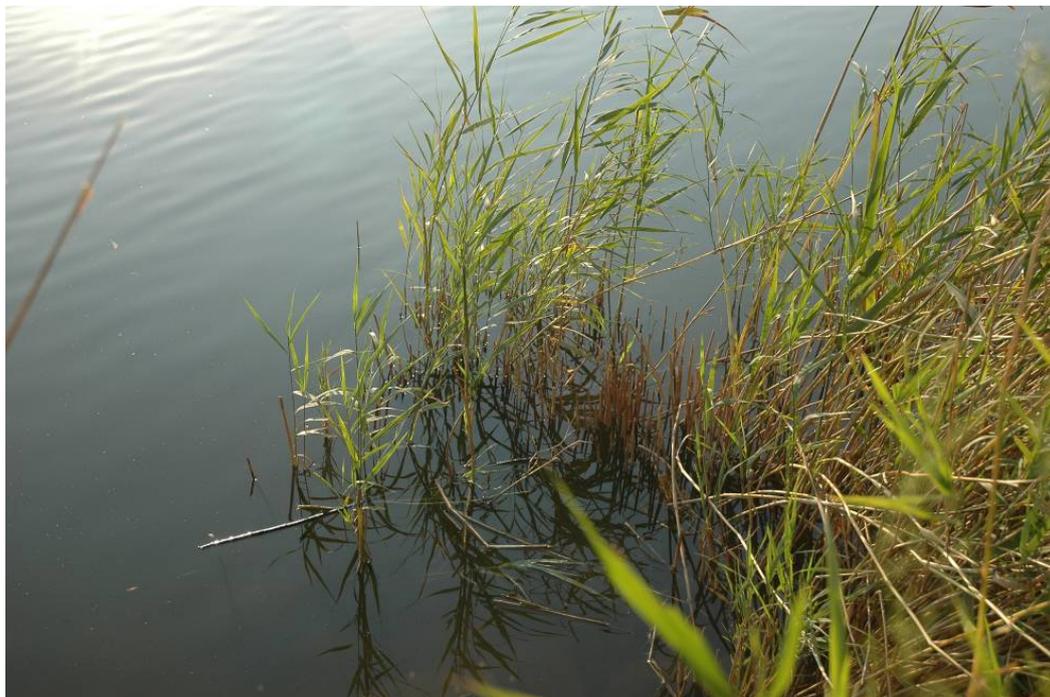
Figure 9.28: Common reed “outlier”, with visible damage from wave action: broken blades and puny shoots (Section 12, 13.09.2006 / at low water)

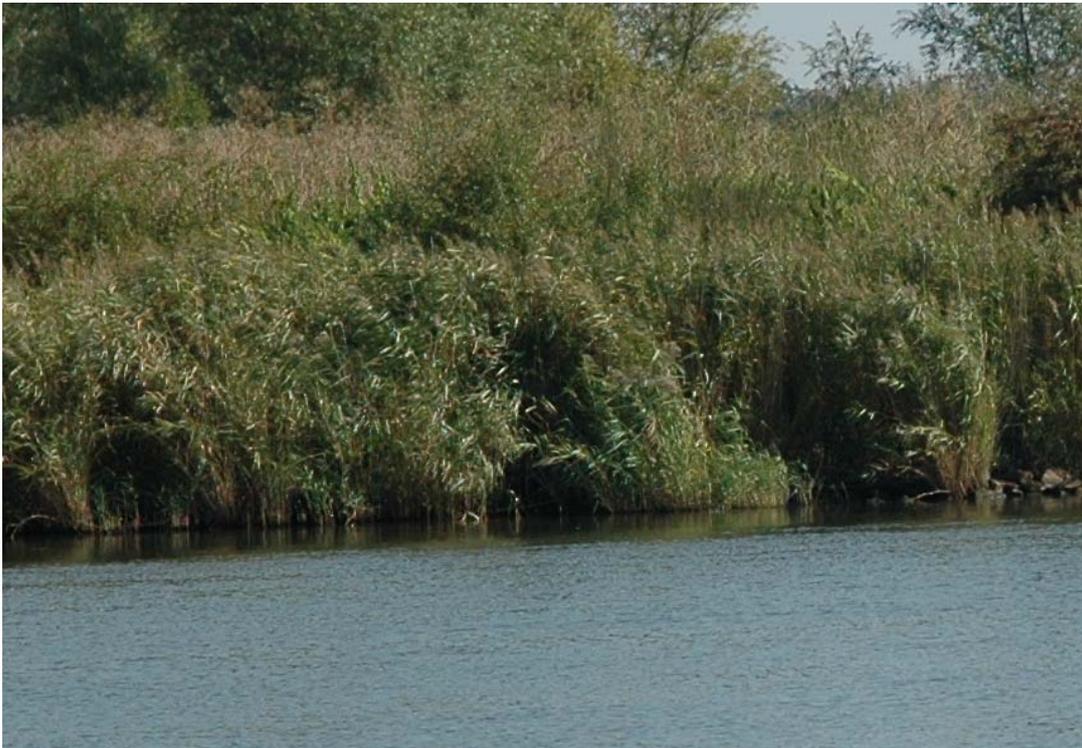
Figure 9.29: Reed beds of common reed provide good erosion control, even on a bank section that has not been flattened and without a fascine as protection (Section 15, on 13.09. 2006, at low water)

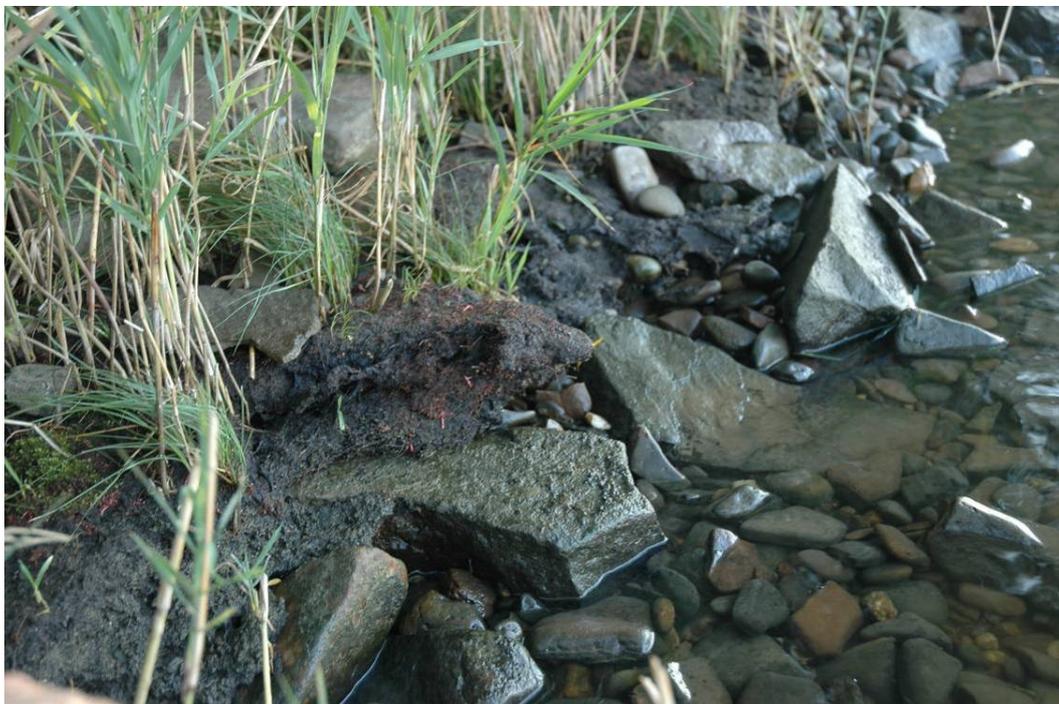
Figure 9.31: More erosion of fine material close to the surface takes place under the willows (Section 10) than under common reeds because there is no continuous grass layer (14.09.2006, at low water)

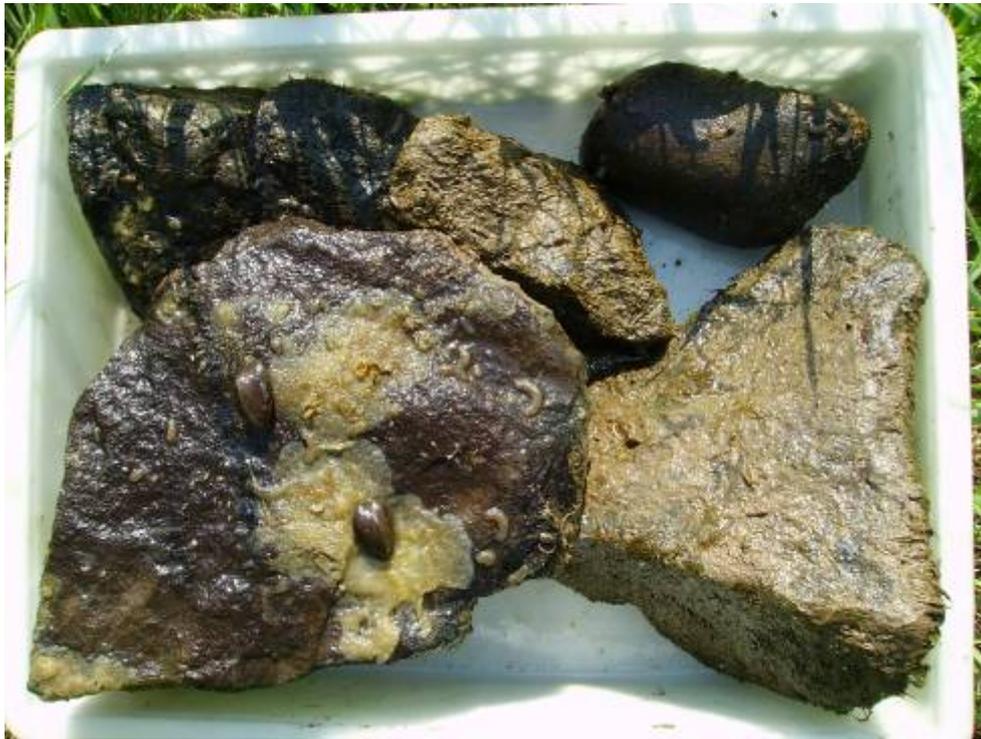
Figure 10.7: Typical hard substratum sample (River Weser at Stolzenau)

Hard substratum (= riprap) was carefully removed from the water and placed in a plastic basin (Figure 10.7), until the bottom of the basin ($1/8 \text{ m}^2$) was covered.
