# Paper 111 - Technical-biological Bank Protection on Waterways with high Traffic Frequency – First Experience Gained from a Test Stretch at the River Rhine with regard to Bank Stability

FLEISCHER, P.; SOYEAUX, R.

*Bundesanstalt für Wasserbau (BAW; Federal Waterways Engineering and Research Institute),  
Karlsruhe, Germany*

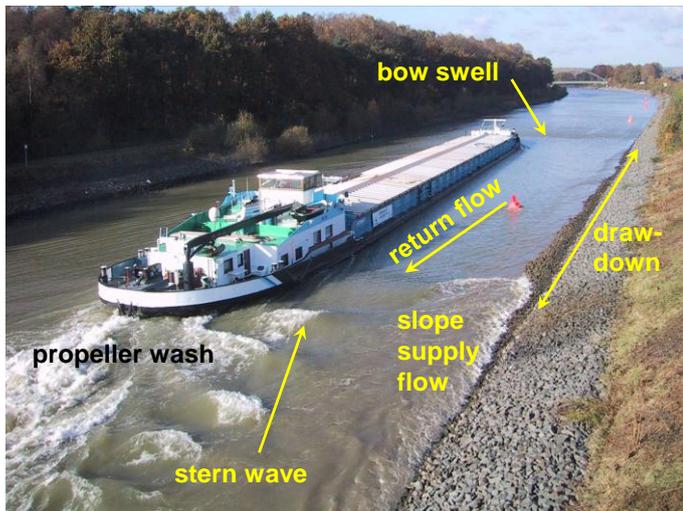
Figure 1: Types of ship-induced load

waterway, which causes local and temporary changes to the water surface and the flow of water around the ship as a result of the interaction of ship and waterway. Here, a distinction is made between primary and secondary waves. A primary wave is defined as the sequence consisting of bow wave (including bow swell) ahead of the ship, water level drawdown alongside the ship and the stern wave aft of the ship (Figures 1 and 2). The associated flows

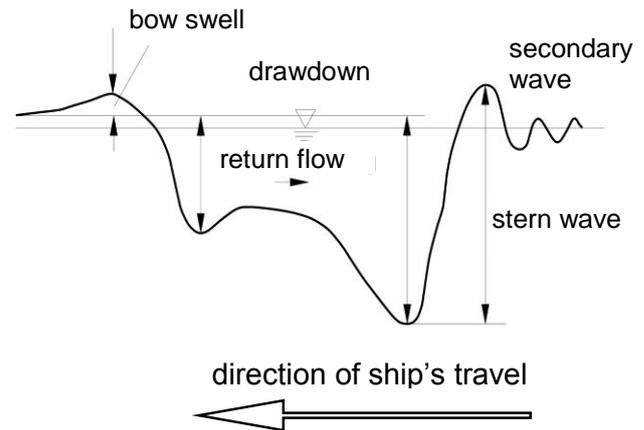
Figure 2: Diagram of the changes in water level at the banks

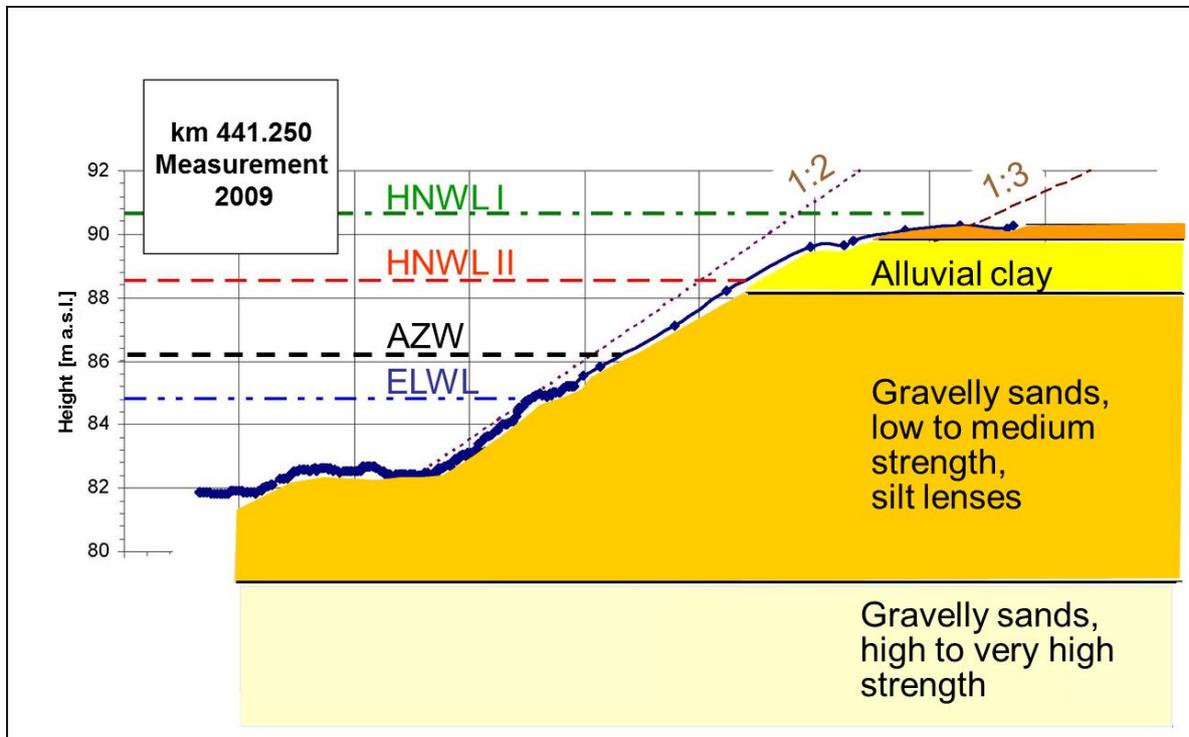
Figure 3: Cross section of bank with soil layers and relevant water levels

low water level (ELWL) and the highest navigable water level (HNWL) – Fig. 3.

Before the construction measures, the inclination of the slopes was usually between 1:2 and 1:3. The original bank protection measure was riprap made from LMB<sub>5/40</sub> armour stones (layer thickness approx. 60 cm to 90 cm). Underneath, a mixture of armour stones and soil can be found down to a depth of 60 cm. At certain points, old pavement still serves as a bank protection measure. Investigations of the subsoil in the area of the slope showed that below a 1.50 m to 2.50 m thick layer of alluvial clay the soil consists largely of gravelly sands (see Fig. 3).

exposed to the greatest hydraulic load – as a result of constant wave action at mid-range water levels and the longest and highest submergence during high water. The flow velocities measured close to the bank (5 m from the bank) during the higher water levels in 2012 (approx. 88.30 m above sea level; see Figure 3) ranged between 0.3 m/s and 1.1 m/s.

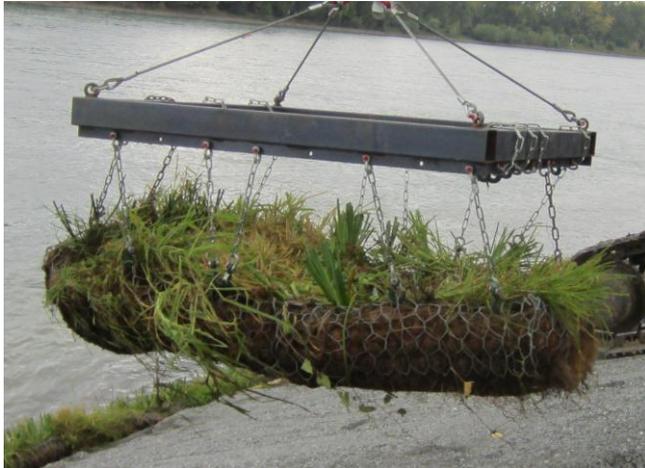
Figure 4: Reed gabions during installation on a granular filter (TF 5)

For the technical-biological bank protection measures, which were installed after the removal of the riprap, prefabricated elements such as reed gabions (TF 5; Fig. 4), stone mattresses (TF 5) and vegetation mats (TF 7; Fig. 6) were used as well as willow brush mattresses (TF 2 and 3; Fig. 5), which were made from local willow branches. The vegetation mats were pre-cultivated during one growth season.

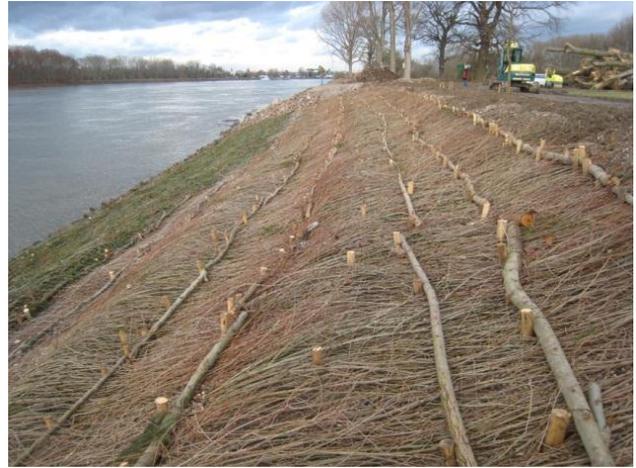
Figure 5: Willow brush mattresses immediately after installation (TF 3)

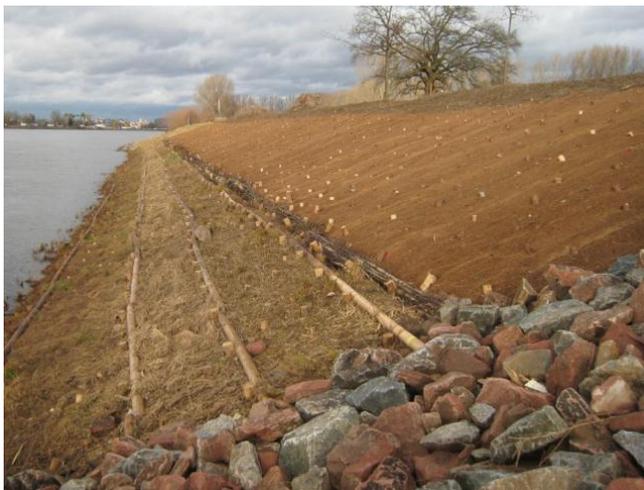
Figure 6: Vegetation mats on filter fleece and woven coir fabric over hydroseeding immediately after installation (TF 7)

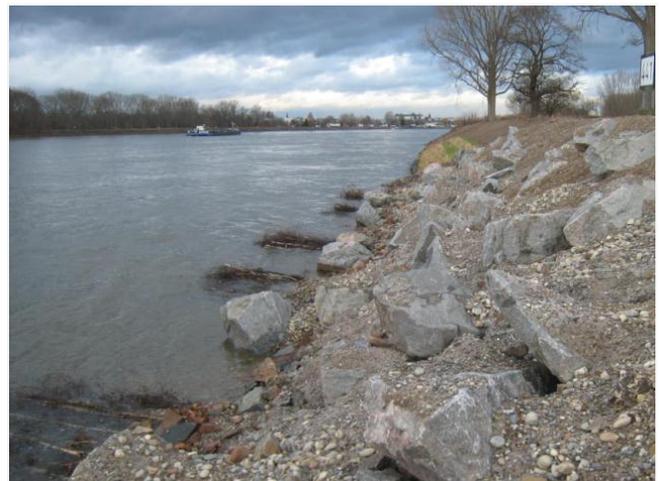
Figure 7: Riprap with gravel fill, groups of individual stones, dead wood fascines (TF 4)

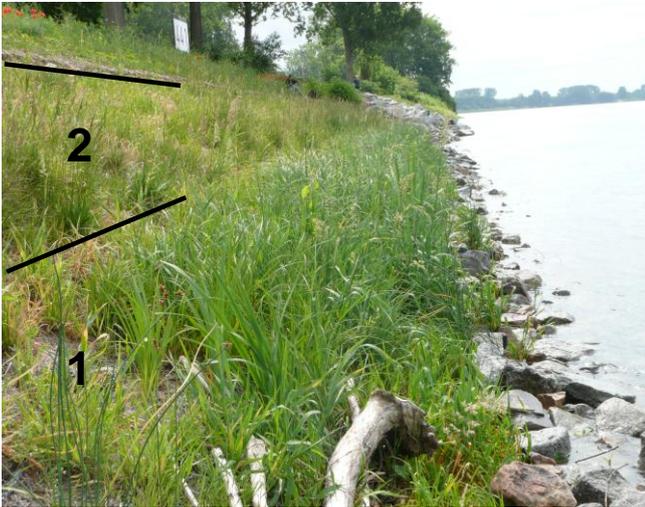
Figure 8: TF 5, lower bank zone on 06.06.2012 (looking upstream)

Figure 8 shows the state of this zone (marked with “1”) before it was submerged, and Figure 9, immediately afterwards. In the long term, however, the vegetation was able to recover, and its protective function was thus not impaired.

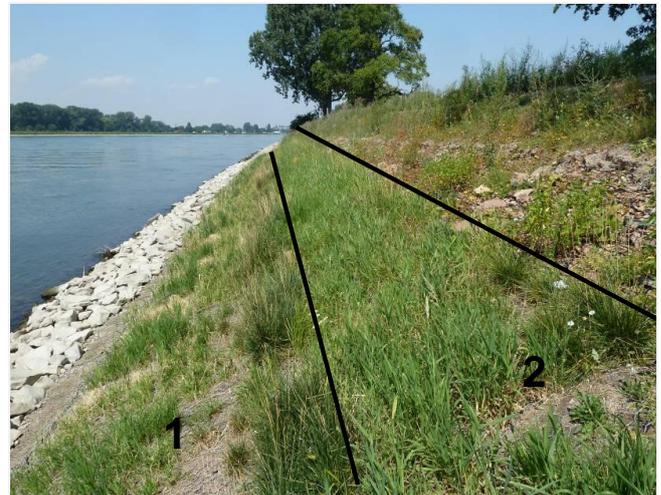
Figure 9: TF 5 in late July 2012, after having been submerged for six weeks (looking down-stream) - loss of vitality

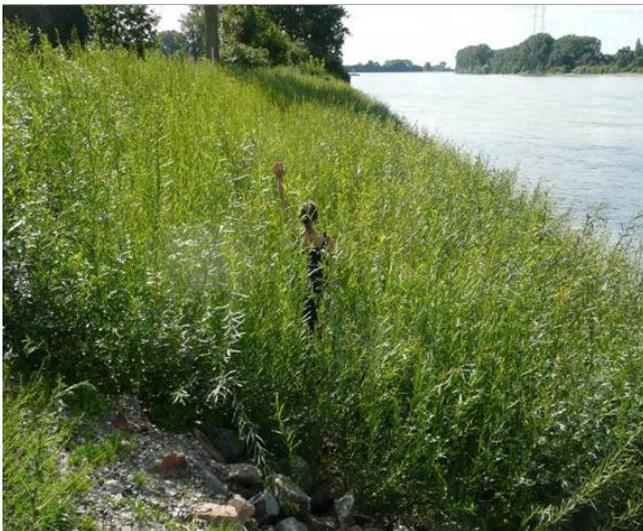
Figure 10: Willow brush mattresses in TF 3 (July 2012)

The willow brush mattresses (mainly consisting of purple willow and white willow, Test Fields 2 and 3) have, in general, developed well on the 1:3 incline of the bank slope (Figure 10 compared with Figure 5). By October 2012, shoot lengths of up to 2.5 m had been reached. Despite repeated submergence, only limited soil displacement was noted. At the downstream end of Test Field 3, the willow roots were dug free in November 2012 in order to assess root development here. The roots were uncovered in two places at different depths over an area of 1.0 x 0.5 m in each case (Figure 11). This revealed a relatively dense root system, with root lengths of up to about 60 cm, which had already developed after the first growth season. On the basis of this root formation, a clear increase can be assumed in the shear strength of the soil close to the surface. Furthermore, in the zone where willow branches were installed, a layer of finely intertwined

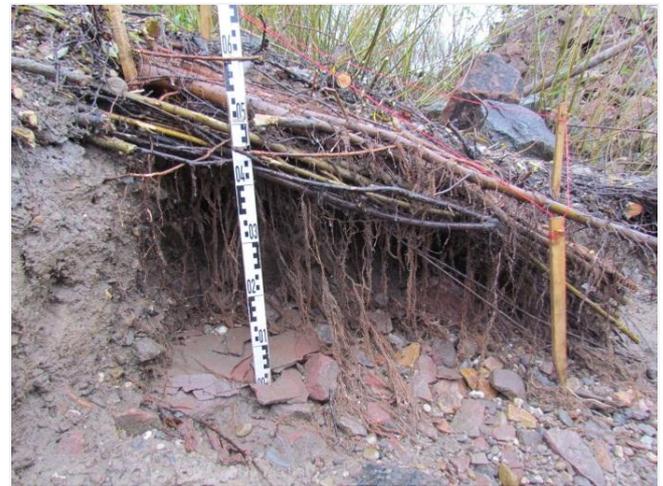
Figure 11: Excavation of roots in TF 3 (20.11.2012)

roots, a few centimetres thick, has formed, which increasingly provides better protection from surface erosion. Further excavations are planned in the next few years, also in the other test fields.

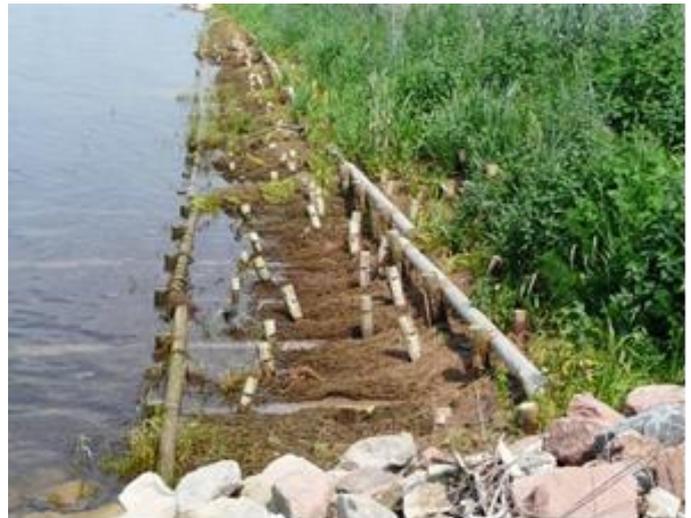
Figure 12: The vegetation mats in the lower slope zone, subject to heavy load (30.05.2013) – TF 7

the fine roots are torn out again. Stakes that have become loose or have been displaced must be renewed repeatedly. Figure 12 shows the lower slope zone in Test Field 7, which was subject to considerably stronger hydraulic load up to about 1 m above the AZW. In comparison with the well developed growth in the bank zone just above this, investigation here revealed a destroyed vegetation mat, largely devoid of growth, while the filter mat underneath was partly exposed. The sheep wool fleece that had been used in some places had been almost completely dispersed in just a few months, which meant that these areas no longer had any protection against erosion. Soil erosion that has already taken place can be clearly seen in Figure 12 through the position of the cross-bars. To ensure the stability of the slope, it has already been necessary to secure the lower slope zone with armour stones in some places.

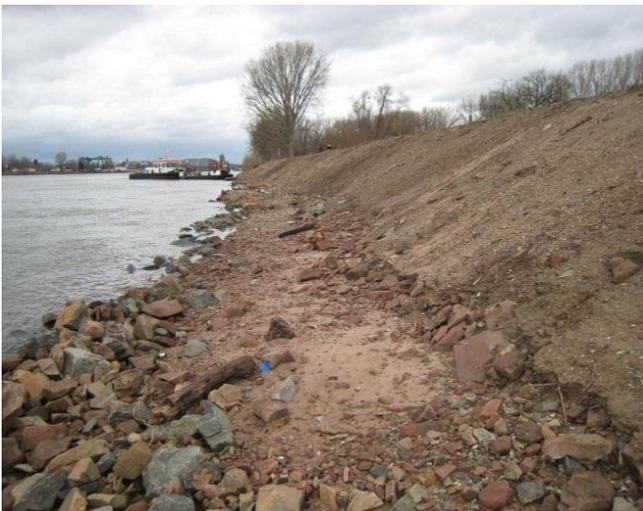
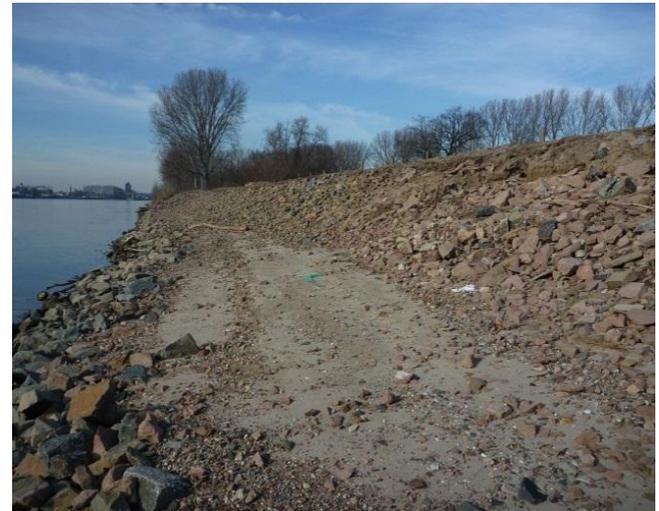
Figure 13: TF 9 without slope protection (14.12.2011)

Figure 14: TF 9 without slope protection (22.02.2012)

Test Field 9, which remained without bank protection measures after removal of the riprap revetment above the AZW, demonstrates that – given the current hydraulic load and the total lack of bank protection – erosion and sliding of the slope will occur, as expected, with in-creasing frequency (Figures 13 and 14). Whether the hinterland at this section of bank, with its limited dynamic activity, is adequately protected by the willow stem cuttings, and their root systems, that were planted in two rows at the transition between the slope and the level ground will be demonstrated by the future development.
