ARIZONA STATE GOVERNMENT BRIDGE SCOUR PROGRAM – A PRACTITIONER’S PERSPECTIVE

This paper will feature the scour countermeasures installed at three typical sites around the State. One such site encounters severe long term degradation. For this site, the countermeasure, comprising a concrete floor and an energy dissipater, under super critical flow conditions is discussed.

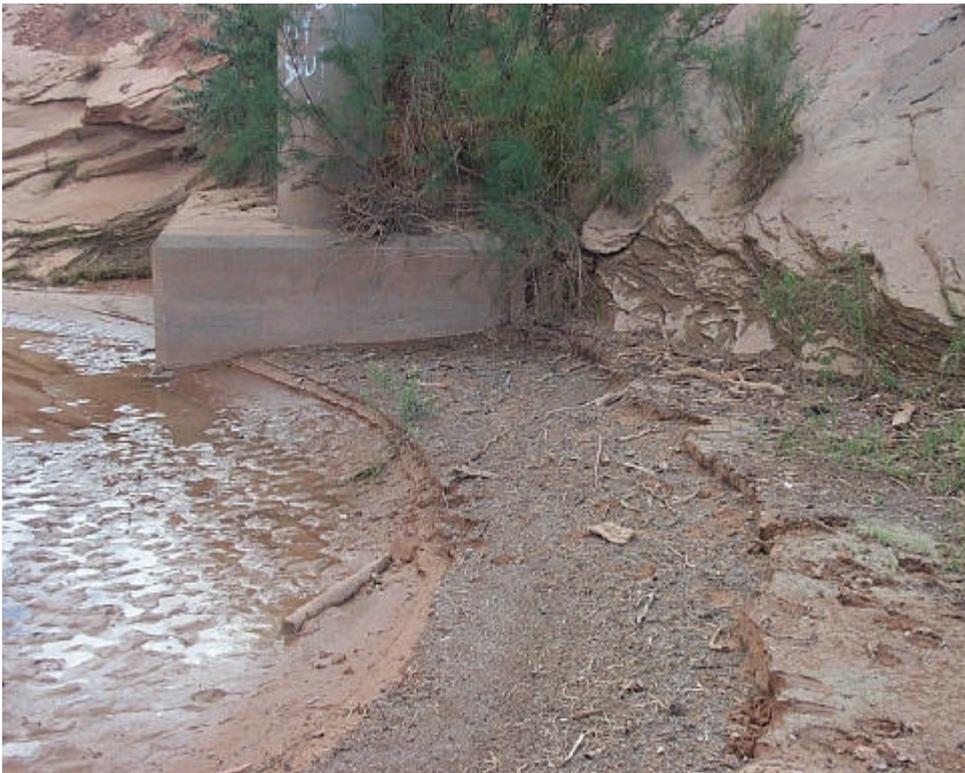
Figure 1 The scoured spread footing foundation prior to installing the countermeasure

This site is located towards the northeast part of the state. The spread footing foundation was initially thought to be on bedrock. However, Figure 1 illustrates that recent flash floods have caused the material under the footings to erode. There is a ten percent drop of the streambed across the bridge. A follow up geotechnical investigation indicated that the underlying Lukachukai Sandstone

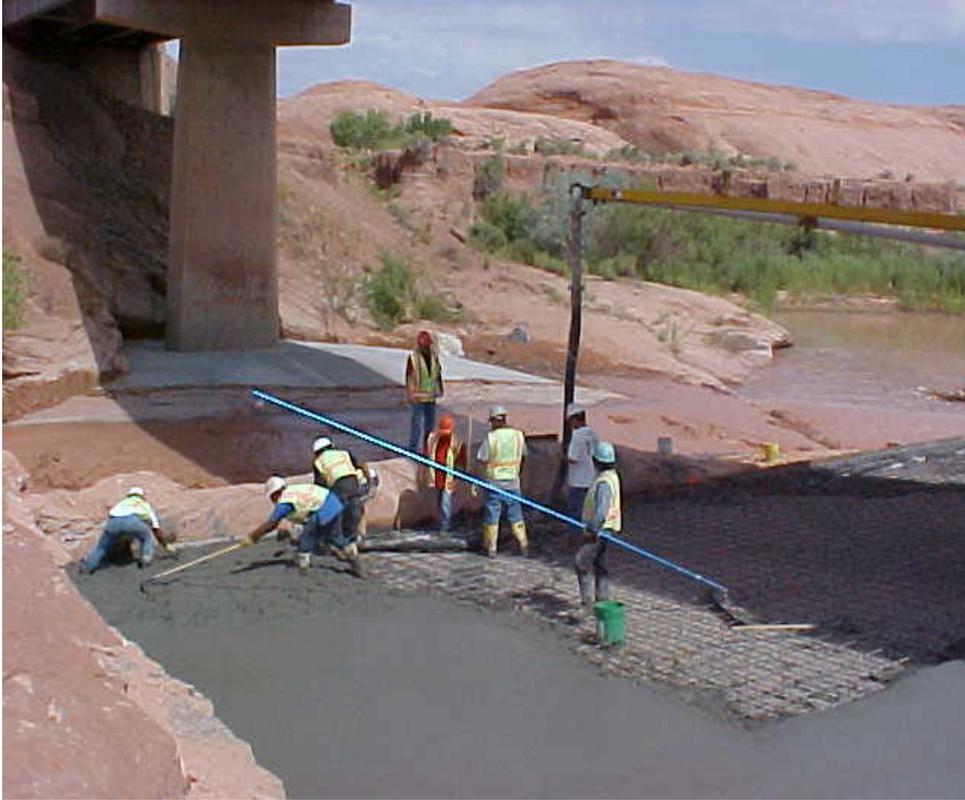
Figure 2 The spread footing foundation after during the installation of the countermeasure

Based on these considerations, a reinforced concrete apron with cut off walls was proposed around each spread footing as the countermeasure. The installation of the reinforced concrete armor around the pier is depicted in Figure 2. It may be noted that the raised armor is anchored to the existing sandstone formation with cut off walls embedded into the sandstone sufficiently away from the footings of the pier.
