STABILITY OF OLD STONE GROINS IN THE KATSURA RIVER DURING FLOODS

Key Words : *Old stone groin, Two-steps deflection of flow, Stability of groins, Velocity distribution*

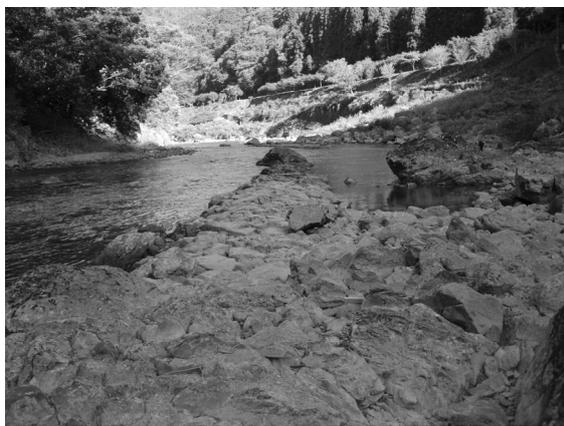
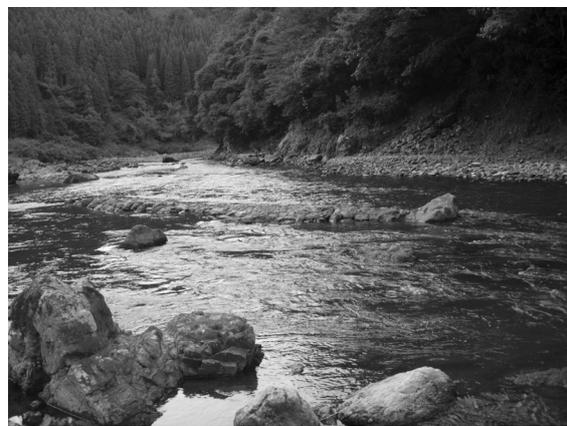
Photo 1 The old stone groins located in Asahigase of Hozu Gorge

There are pools and riffles on the studied site, and stone groins are set on riffles. The old stone groins are located on the riffle of Asahigase in the middle of Hozu Gorge as shown in Figure 1. Field surveys were done in 2005 and 2007, and the form, flow velocity around them and stone size were measured. The groins are composed of two groins and the two groins are shown in Photo 1. Each groin has a big rock at the

The upstream groin

The downstream groin

condition. The velocity for downstream groin is 86 percent of the value for the upstream groin. As it is considered that the groins are in the tight bond condition shown in Photo 1, the groins would not be broken by floods when the flow velocity is less than 7.3 m/s. The occurrence probability of such rapid flow is very low, because valley slope of the site is very mild. The slope figured by using a topographic map is milder than 1/400.

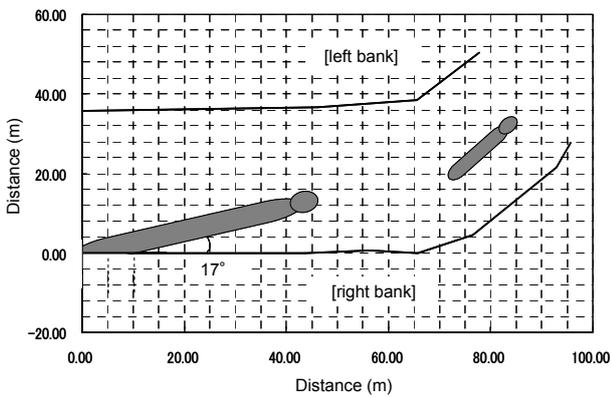
Figure 2 Layout of the old stone groins in Asahigase

downstream end and stone-made part on the upstream side. Figure 2 is the layout of two groins.

The upstream groin is set on the right hand side of stream and the other one is set in the middle of

stream. Approaching flow is deflected by the first groins to the channel center and the second groin is laid to deflect the flow again. This pair of groins is called as a two-step groin in this paper on the basis of the doubly deflecting function of them.

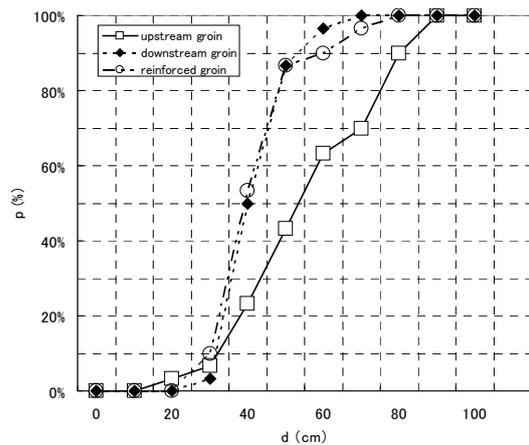
Figure 3 Cumulative distributions of stone diameter of three groins

The height of groins is nearly equal to normal water depth of around 1.0 m. As coefficient of river regime, which is the ratio of maximum to minimum discharge, is very large in Japanese rivers, the groins are destroyed by high speed flow during floods. To evaluate the stability of groins, major and minor axis lengths on the surface were measured in the field survey. Mean diameter of each stone was evaluated by using the mean value of major and minor axis lengths. Figure 3 is the cumulative distribution of mean diameter of 30 stones for three groins. Data of a reinforced groin located in Ose shown in Figure 1 are also shown in the figure. Stone sizes made up of upstream groin are larger than those of downstream one. And the sizes of downstream groin are as same as those of the reinforced groin. It seems that flow velocity around the downstream groin is lower than the velocity around the upstream one, because the both groins have retained their forms in the same place.

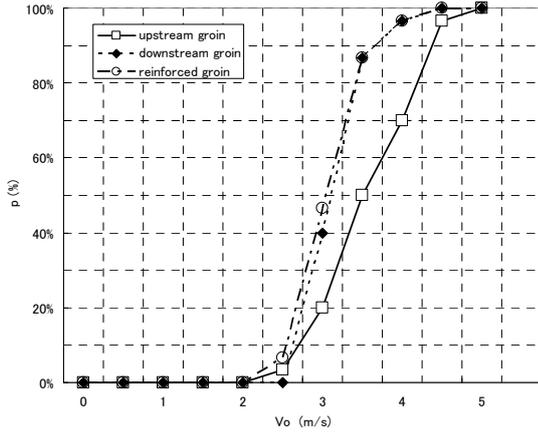
Figure 4 Cumulative distributions of critical velocity, V_0 , in the loose bond condition

Figure 4 and Figure 5 show the cumulative distribution of velocity, V_0 , for the two conditions. In the loose bond condition, V_0 for d_{50} is 3.1 to 3.6 m/s. And V_0 for d_{50} is 7.3 to 8.4 m/s in the tight bond

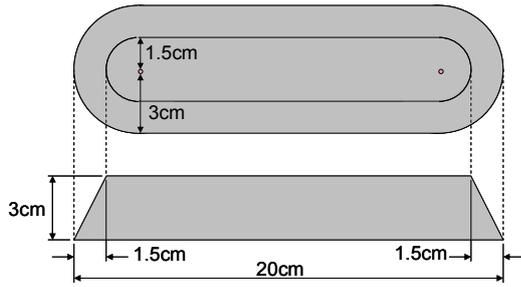
Figure 6 Model of Groin

The downstream groin has been made up of smaller stones, and the both groins are not reinforced. This thing implies that the velocity of impinging flow to the downstream groin is slower than the velocity to the upstream one. To investigate the magnitude of velocity around a two-step groin, laboratory experiments were conducted by using a model groin shown in Figure 6. Two models were made of mortar and set them to deflect the flow by the first groin toward the second groin, deflecting the flow again by the second. The layout of two groins is shown in Figure 7. This layout was set up from velocity measurements of 12 different cases. Longitudinal and

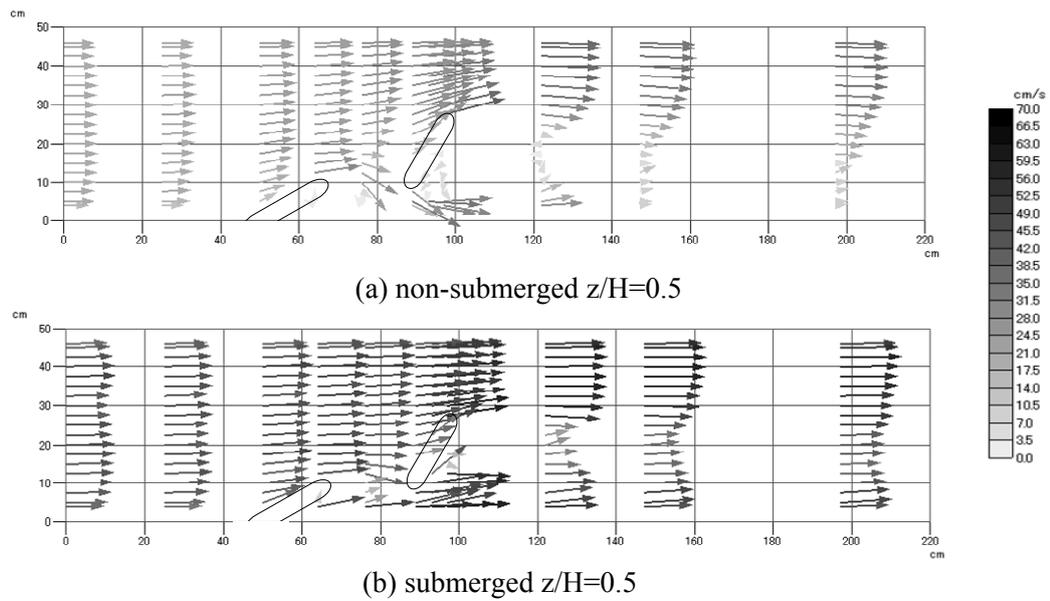
Figure 8 Distributions of velocity vectors

Figure 8 is the distributions of velocity vectors at the half level of groin height, $z/H=0.5$, in the non-submerged case and submerged case. Figure 9 shows the contours of velocity normalized by the discharge velocity of approaching flow. Approaching flow is deflected by groins and main stream is converged to the left side of channel in both cases. Velocity around the downstream side of the second groin becomes faster. As a big rock is set at the downstream end of the groin mentioned before, it is able to avoid being washed out by rapid flow. On the other hand, some parts of flow run through the interval between two groins. However, the velocity of impinging flow to the upstream side of the second groin becomes slower than the discharge velocity in submerged case. This reduction of velocity is observed in this layout case. It means that the layout of two groins is a factor of avoiding disruption by floods.
