SCOUR MONITORING AROUND THE BREAKWATER HEAD AT MAILIAO HARBOR

Meng-Yi CHEN¹ and Jyh-Cheng CHU²

¹Senior Engineer, Ph.D., CECI Engineering Consultants, Inc., Taiwan
(26F.,No. 185, Sec. 2, Sinhai Rd., Taipei 10637, Taiwan)
E-mail:mengyi@ceci.com.tw

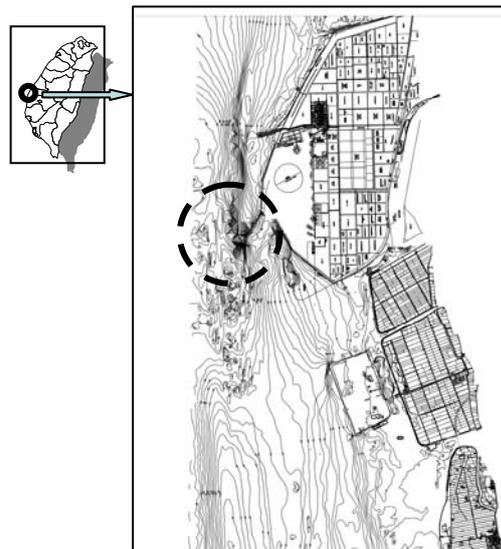
Figure 1 Mailiao harbor. Circle indicates the location of WB III head

Mailiao harbor, located on southwestern coast of Taiwan (figure 1), constructed in compliance with the necessities of the Sixth Naphtha Cracking Complex Project in Taiwan is of importance in transporting raw materials and processed products in the offshore Primary Industrial Zone in Yunlin, Taiwan. During construction of the west breakwater, it was paused for five to seven months every year due to the severe construction condition caused by the northeastern monsoon. Therefore, six scour locations had been observed, which are at caisson

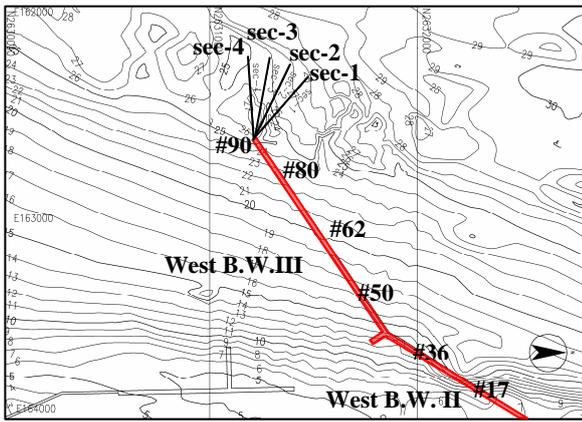
Figure 2 Seabed topography in May 1996 prior to WB III was built.

Figure 2 displays the bed topography in the neighborhood of WB III in March 1996 when WB III has not been built yet. It can be seen that prior to the construction of the breakwater, the slope of seabed in the near shore region where the water depth is less than 25m is rather mild. The slope of seabed in the region where the bed level is between

-5m~-15m is about 1:100 and where the bed level is between -15m~-25m is about 1:80. On the other hand, the bed topography with water depth greater than 25m is more complex and irregular, but the overall slope is milder. It seems that current might be the dominant force on the bed topography variation where the water depth is greater than 25m.

The past surveys show that severe scouring occur in between 30° to 75° measured clockwise from the extended centerline of WB III. Hence, the historical changes of bed topography along profile sec-1 to sec-4 indicated in figure 2 is further investigated and the results of sec-1(75°), sec-2(60°), and sec-3(45°) are shown in figure 11, figure 12, and figure 13, respectively. The bed level and location of lowest point along each profile (sec-1 to sec-4) are

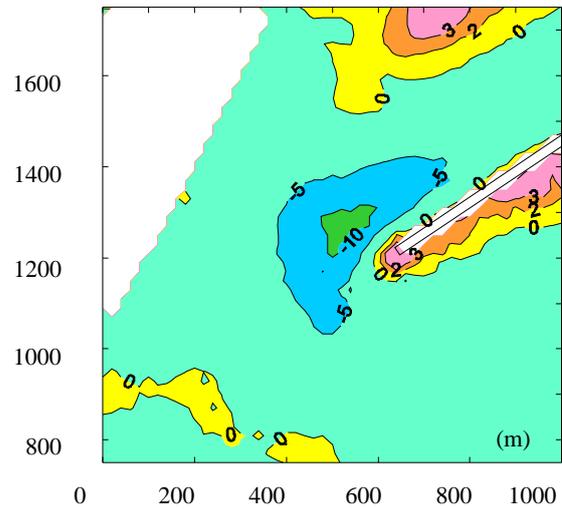
Figure 3 Accretion/Erosion near the head of WB III (May 2001-March.1996)

After the last caisson (#90) of WB III was placed in September 2000, a scour hole quickly formed. Two field measurements in May 2001 and April 2004, after the completion of WB III and prior to the construction of the submerged breakwater, are compared with the bed topography in March 1996, and the results of accretion/ erosion are shown in figure 3, and figure 4, respectively.

Figure 3 shows that in May 2001 just after the construction of WB III was completed a scour hole with maximum scour depth to 12m was formed at about 125m away from the head of the breakwater, 45° from the extended centerline of the breakwater when measured clockwise. Figure 4 shows that in April 2004 the scour extent enlarged both in the northern and southern direction with the maximum scour depth of 25m and the center of scour is about 215m away from the head, 75° from the centerline.

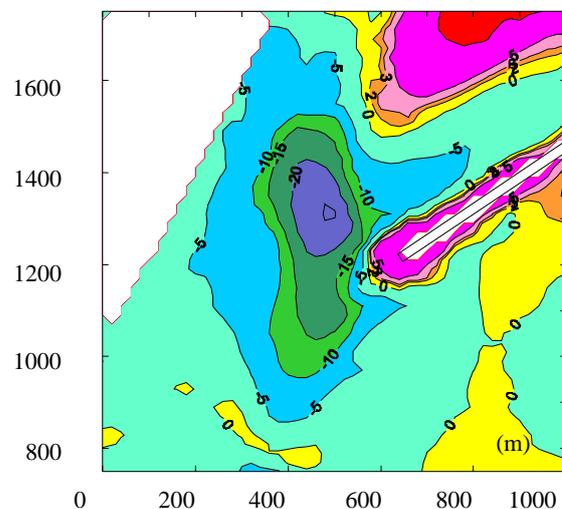
Figure 4 Accretion/Erosion near the head of WB III (April 2004 March.1996)

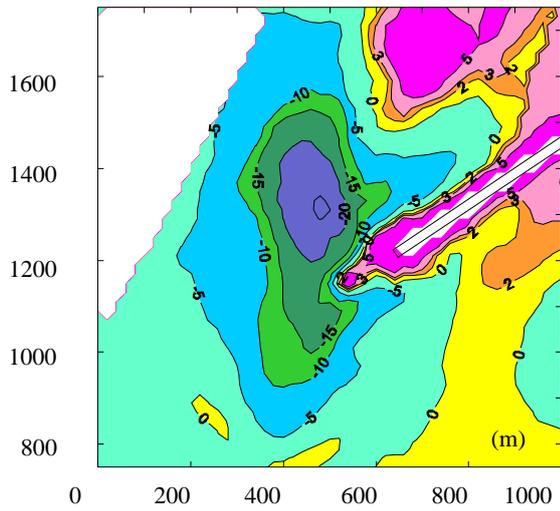
Figure 5 Accretion/Erosion near the head of WB III (April 2005-March.1996)

compared with March 1996. It can be seen from figure 5 the appearance of the submerged breakwater. The reason why a boulder like topography appears at the location of the submerged breakwater is due to bad construction conditions. Figure 6 shows that in May 2006 the extent of the sour hole is reduced significantly. The maximum scour depth was reduced about 4m and the location was moved southward along the submerged breakwater.

WB III was extended by a submerged breakwater with length of 150m and top design level of -24.1m, which was constructed from May 2004 to Jun. 2006. Figure 5 is the accretion/erosion in April 2005

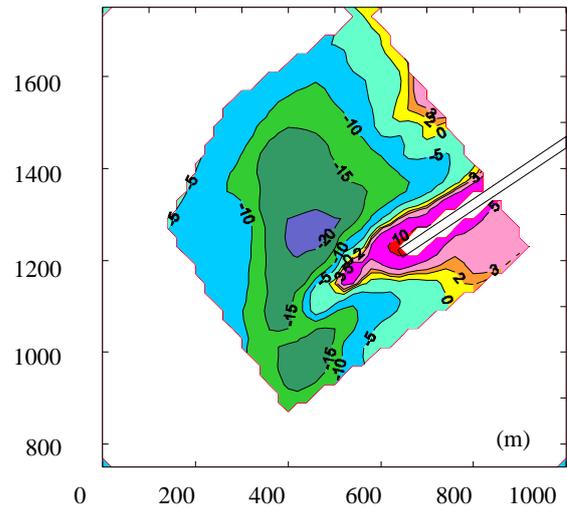
Figure 7 Accretion/Erosion near the head of WB III (March 2007-March.1996)

Figure 7 and figure 8 show that in March 2007 and in August 2007, after the completion of submerged breakwater, the scour hole is gradually

increasing its extent with the width of the region where scour depth is greater than 20m widened from about 100m to 250m, and maximum scour depth of 25m is approximately equal to the maximum scour depth in April 2004.

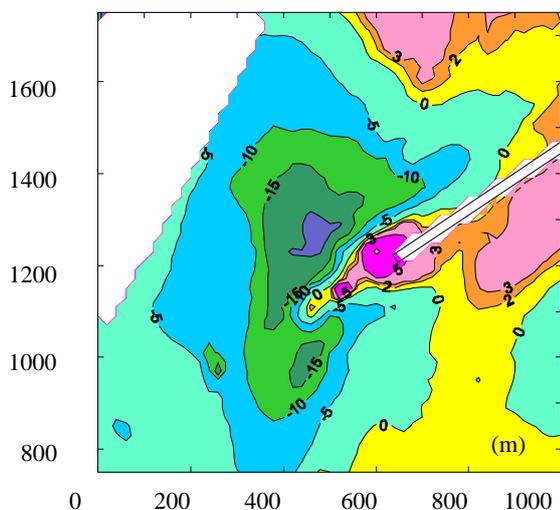
Figure 6 Accretion/Erosion near the head of WB III (May 2006-March.1996)

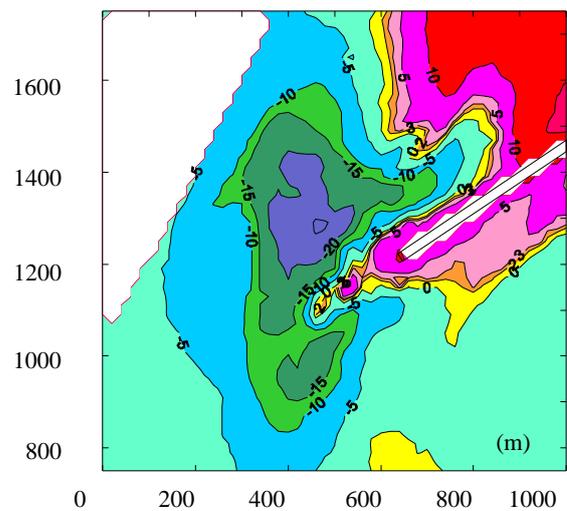
Figure 8 Accretion/Erosion near the head of WB III (August 2007-March.1996)

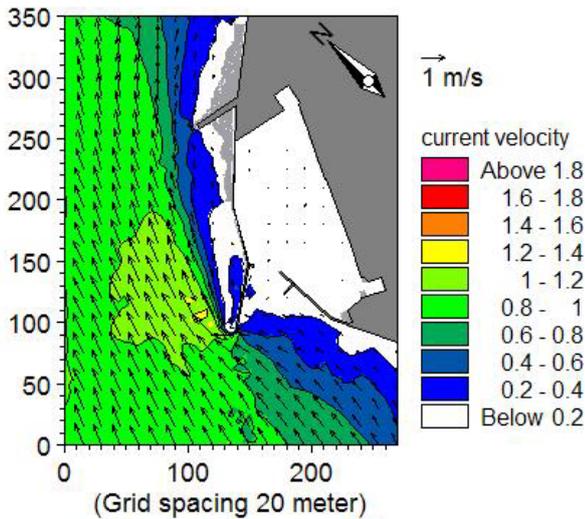
Figure 9 Flow field during flood tide

Flow field simulation is carried out by HD module of MIKE21. Simulation time is from 2001/08/07 00:00 ~ 2001/08/25 24:00 due to the availability of the water level measurements. Figure 13 and figure 14 are the results of flow field during flood and ebb tide, respectively. It shows that during flood tide the flow direction near the head of WB III is from south to north and a clockwise vortex occurs near the west breakwater at sea side. In addition, during ebb tide the flow direction near the head is opposite the flood tide and a counterclockwise vortex occurs near the east side of WB III. The simulated results are validated with a field measurement of current with a good agreement. The results also indicate that the current velocity near the head of WB III during flood tide is greater than the velocity during ebb tide, namely net mass transport is from south to north. Furthermore, the maximum current velocity near the head during simulation period is about 1.2 m/s.

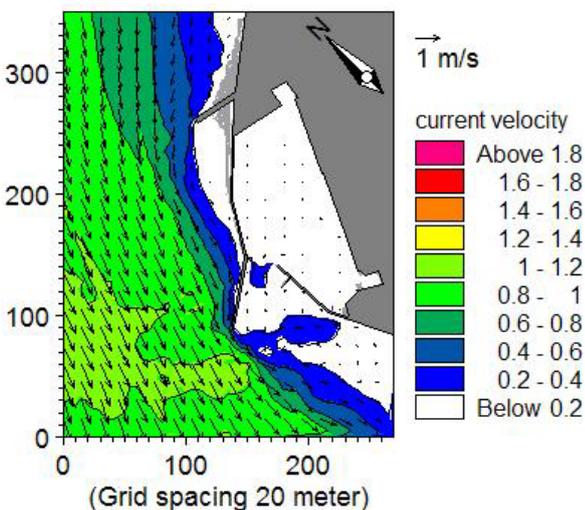
Figure 10 Flow field during ebb tide

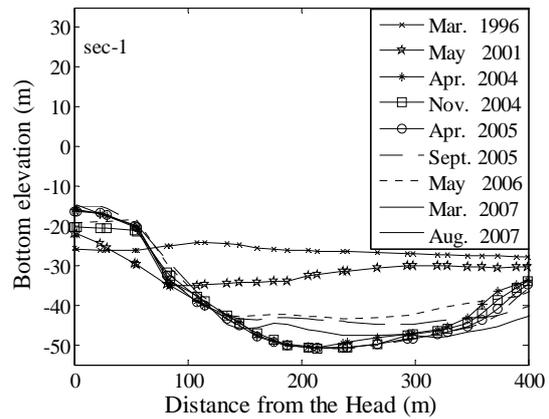
Figure 11 Measurements of seabed level along Sec-1

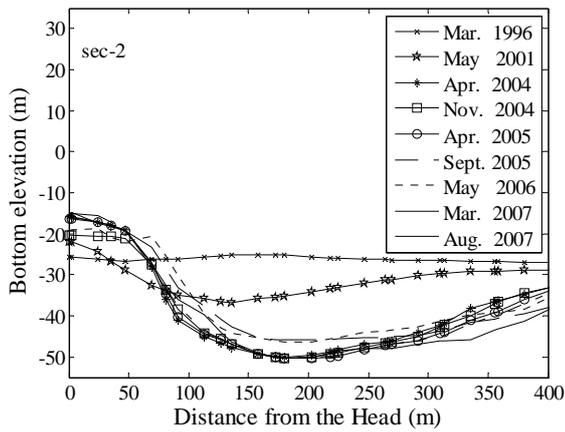
Figure 12 Measurements of seabed level along Sec-2

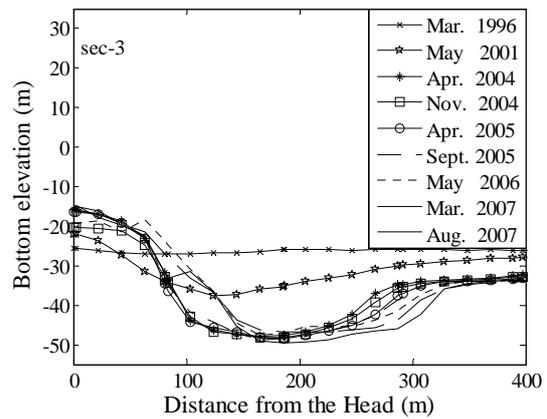
Figure 13 Measurements of seabed level along Sec-3

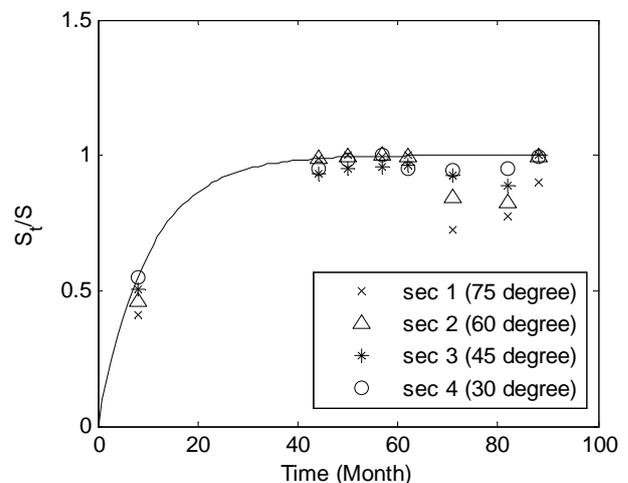
Figure 14 Time development of scour depth

where S is the scour depth corresponding to the equilibrium stage and T is the time scale of the scour process. Figure 13 displays the time development of the scour hole in which Time=0

indicates March 1996. It can be seen from figure 13 that the equilibrium scour depth seems to be reached, and the time scale of the scour process is about 10 months. In addition, the simulation of current velocity near the head indicates that the net flow in a tidal period is in north direction, which shows the scour is more severe at the north side of the head of WB III. It seems so far the scouring has reached the equilibrium stage, however for the safety of the structure monitoring on a regular basis is suggested.
