## DYNAMICS OF EROSIVE PROCESSES IN THE NIZHNYAYA-VOLGA PRIKASPIY REGION

**Key Words :** *Erosive process, Volga and Akhtuba rivers, slope, sandy-clay deposits, landslide deformation.*

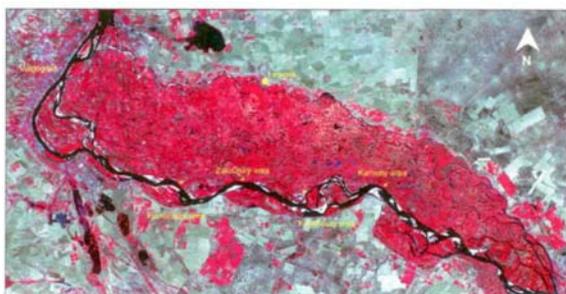
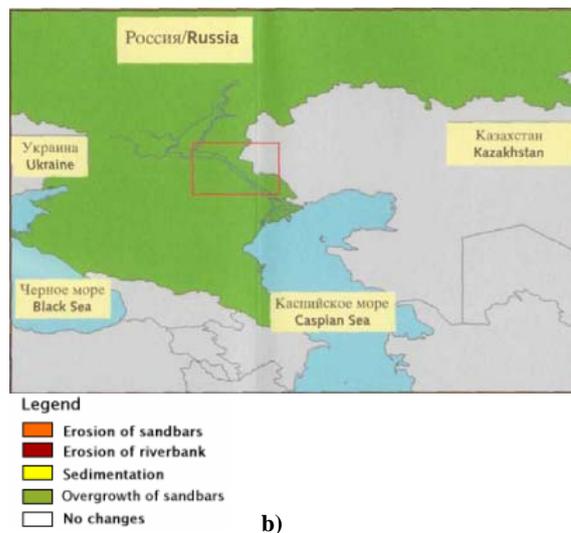
a)

**Fig.1** Morphological changes of Volga-Akhtuba floodplain in 1986-1996 (a) and scheme of geographical location (b).

The analysis of satellite pictures of the floodplain territory for the period 1985-2001 and field observations of key sites of the floodplain were conducted to perform this work.

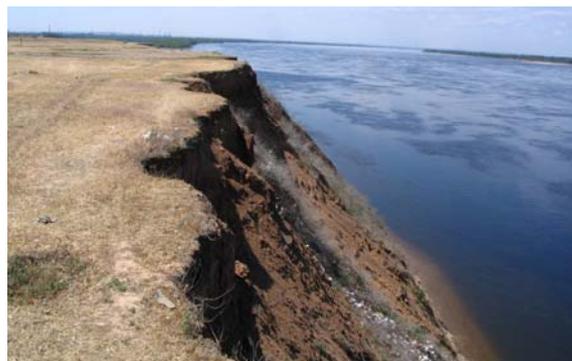
**Fig.2** Erosion of a slope on a Svetly Yar site

Riverside ledge on Svetly Yar site is steep, in the top it is vertical and more flat only in the south part of the area. The slope altitude is from 25 up to 30 m above the low-water level in Volga River. Edge is plain, sandy-clay, with a bias to a channel under a corner 7-10°, width is 15-20 m (Fig. 2).

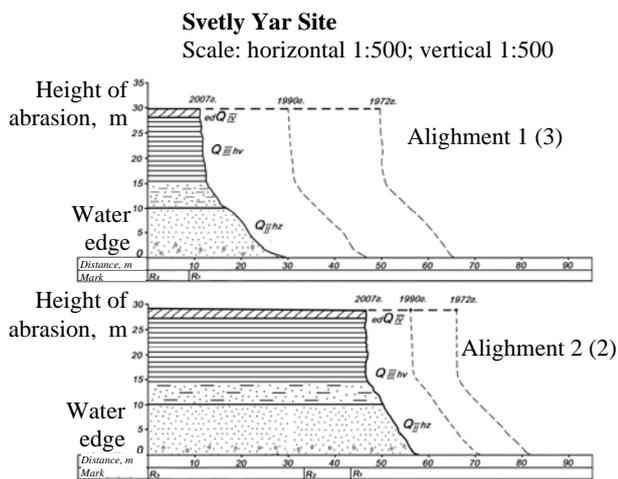
**Fig.3** Structures of a riverside slope of a Svetly Yar site

Tetradic loams, layered clay and clay fine-grained sand (Fig. 3) take part in a geological structure of a riverside ledge. Structures of comparison of a relief for the period of supervision from 1972 to 2007 show an average slope erosion speed at a rate of 0,7 - 1,1 meters a year.

On the Figures 3 and 5 are shown following conventional signs:  $edQ_{IV}$  – recent eluvial-dealluvial deposits – loamy soil;  $Q_{III}^{hv}$  – highquaternary khvalynsky deposits – clay, in there is clay sand in the bases;  $Q_{II}^{hz}$  – middlequaternary hazarsky deposits – silica sand, there is gravel in the bases.

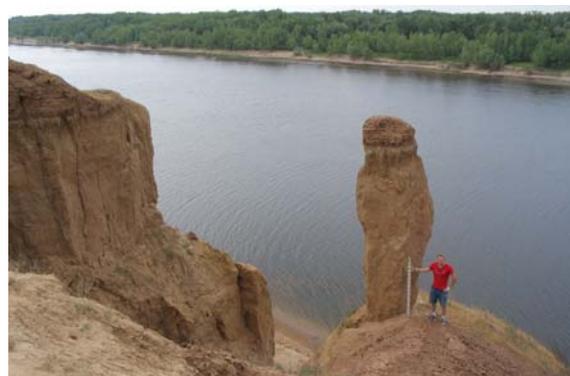
**Fig.4** An erosive slope of Akhtuba River valley

Within the limits the Akhtuba River valley has a sharp turn, this causes an activity of erosion on this site. The valley is asymmetric: its left bank is abrupt, and right is flat (Fig. 4). The width of a channel at horizon of water minus 9-10 m makes about 125-130 m. Depth of the river varies from 0,5 up to 2,5 m, and the greatest depths are dated for the left bank.

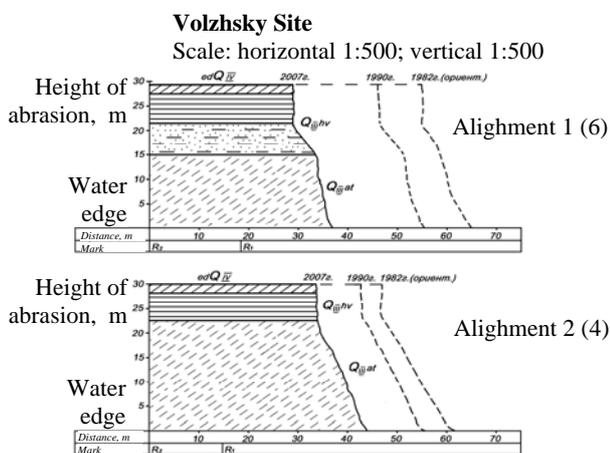
Fig.5 Structures of a riverside slope on Volzhsky site

Loams, sandy loam, sand (Fig. 5) take part in the geological structure of the riverside ledge. The riverside slope is flat, the ledge is abrupt, steep, and it has height up to 20 m. At a sole of the ledge taluses and collapses, large columnar chards of breeds, traces of falls deformations are noted. The beach is narrow and sandy, its width makes 1-2 m. Washout of bank is connected basically with passage of the high water cutting landslide-crumbling accumulations and directly riverside ledge that defines high activity of erosive processes.
