UNDERSTANDING FALLING APRONS – EXPERIENCE FROM THE LOWER BRAHMAPUTRA / JAMUNA RIVER

Knut OBERHAGEMANN¹, Philemon DIGGELMANN² and MUKHLES-UZ-ZAMAN³

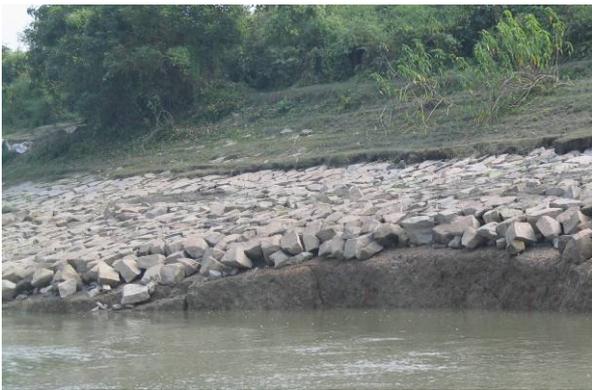
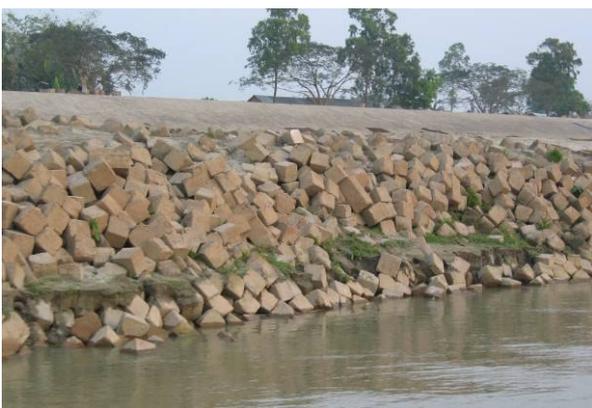
Fig.6 Steep cohesive banks cannot be covered with falling aprons

- (i) more cohesive strata that form steep banks (**Fig.6**). The upper photo shows the failure of pitched rock on clayey soil, and the lower one shows that even a higher pile of concrete blocks does not cover the steeper cohesive bank properly but leaves an unprotected gap above the low water line.
- (ii) recently deposited, very loose sands that are not geotechnically stable at the launched angle (ref. Chap. 2.2).
