PIPING FAILURE IN SUBWAY CONSTRUCTION DUE TO INTERNAL EROSION OF SILTY SAND

Kenji ISHIHARA¹ and Wei F. LEE²

Key Words : Piping, Subway, Internal erosion, Silt, Pinhole test

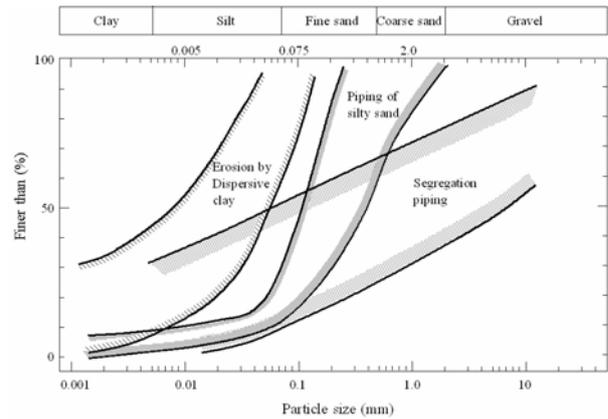
With respect to the piping or erosion, there would be three types of categories to be distinguished depending upon the range of grain size of soil materials in question. These are shown in a graphical form in Fig. 7. The segregation piping has been the target of extensive studies in the past in association with the filter criteria for the design of rock fill dams. There are many studies reported in this context such as those by Terzaghi (1939), Kenny-Lau (1986), Skempton-Brogan (1994) and Sherad (1979).

The outcome of the grain-size analyses for the silty sand at Kaohsiung has shown that the soil there belongs neither to the broadly graded gravelly sands for the segregation piping nor to the dispersive clay related to the erosion or gully formation. In fact, the grain size in Kaohsiung soil lies midway in the range of silt and sand, as indicated in Fig. 7, which is coarser than the dispersive clay and finer than the soils related with segregation piping. Thus, the collapse of the silty sand in the subway construction in Kaohsiung was considered to have posed a new challenge and addressed a novel problem area. The solution for this is not yet settled, but performing some tests was regarded as a useful attempt to shed some light on this problem. In this context, a set of pinhole tests and measurements of specific surface were performed as described below.

Fig.7 Three groups of soils in terms of grain size range associated with erosion and seepage instability.

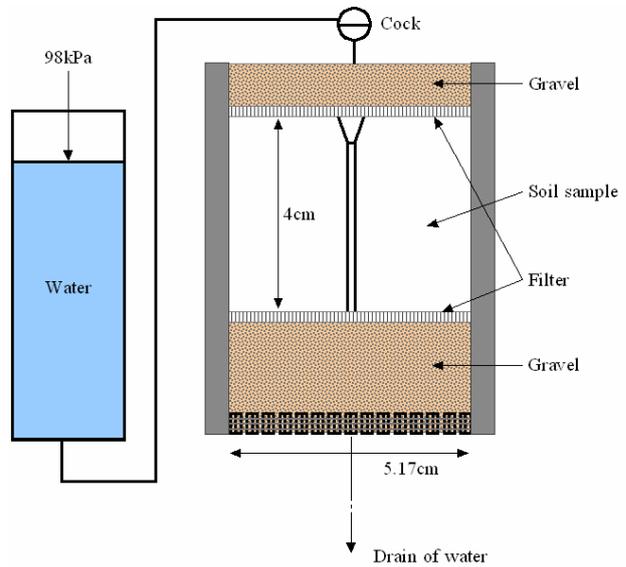
Fig. 8 Layout the pinhole test.

In order to examine the vulnerability of the silty sands at Kaohsiung to the internal erosion or piping, what might be called “Pinhole test” was carried out. The layout of the test system is displayed in Fig. 8. The sample 4cm thick and 5.17cm in diameter was sandwiched by highly pervious gravel layers at the top and bottom with filter meshes placed between the sample and gravel. A vertical hole 3mm in diameter was drilled as shown in Fig. 8. Water was then circulated through the sample. In this type of test, water is supposed to flow mainly through the pinhole. If the silty portion is erodible, the water coming out is expected to be muddy, but otherwise the water transparent.

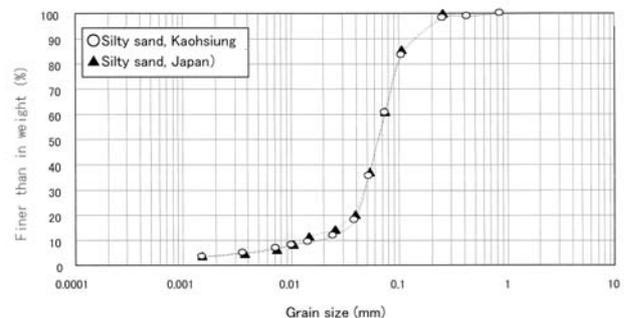
Fig. 9 Grain size distribution curves of silty sands used for the pinhole tests.

The silty sand from Kaohsiung tested had a grain size distribution as shown in Fig. 9. For comparison sake, another material from a site in Chiba, Japan, was secured and used for the same testing. The grading of this Japanese soil was almost the same as indicated in Fig. 9. It is to be noticed that both silty sands had an average grain size of about D₅₀=0.075mm and fines content was about 50%. The physical characteristics of these two materials are shown in Table 1. The two samples were compacted so as to have the same wet density of 1.902 g/cm³.
