Collapse Scene Investigation (CSI) Carmel River Bridge Failure

Catherine M.C. Avila, P.E., D.WRE, MSCE, MBA

Key Words : Carmel River, Bridge Scour Failure, Detour Cost, Temporary Bridges

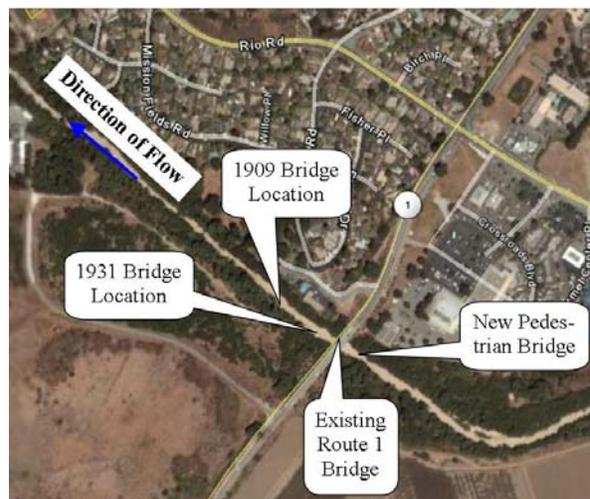
Figure 2: Past, Present and Future Bridges at the Site (basemap from googleearth.com).

As shown in Figure 2, there have been three state highway bridges at the site and a pedestrian bridge is proposed.

The earliest bridge with records available was constructed in 1909. This 1909 timber bridge was replaced in 1934 with a bridge upstream because the timber piles and deck were rotting and the bridge was settling. The 1934 bridge was replaced in 1995 with a

reinforced concrete box girder bridge upstream when three spans of the 1934 bridge washed into the river on March 10, 1995. A pedestrian bridge is currently proposed upstream of the 1995 Route 1 Bridge as part of a pedestrian and bicycle corridor planned by the Transportation Agency of Monterey County (TAMC).

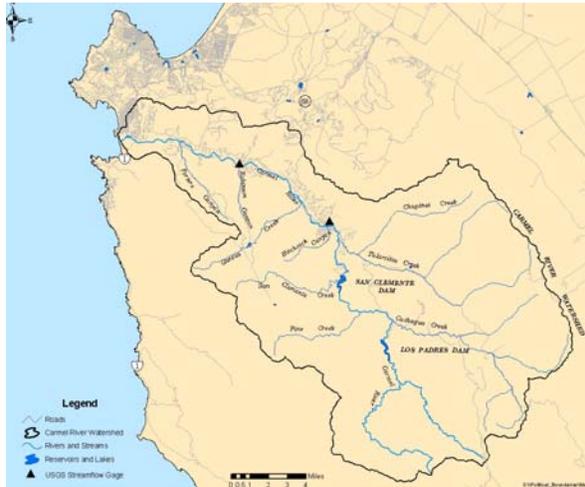
Figure 3. Carmel River Basin (from Monterey Peninsula Water Management District).

The Carmel River is a central California coastal stream that drains a 23.7 sq meters watershed to the Pacific Ocean (Figure 3). The river has two dams on its mainstem: the 25.9 m high San Clemente Dam located at Rivermile (RM) 18.6 and the 42.1 m high Los Padres Dam located at RM 23.5.
