## **BAW Letter No. 5 – May 2012**

### **G-114 G**

#### **Technical-Biological Bank Protection Measures Applied on Inland Waterways – field test on the River Rhine, km 440.600 to km 441.600 (right bank)**

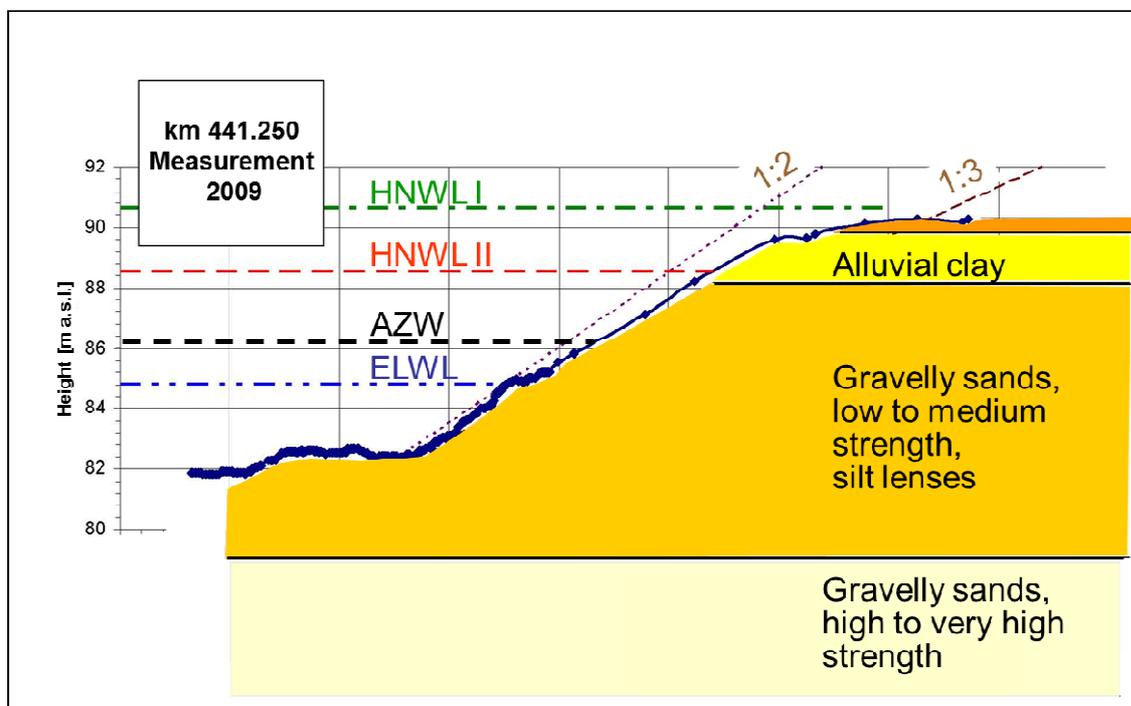
Figure 1: Cross section of bank with soil layers and relevant water levels

The inclination of the slopes is usually between 1:2 and 1:3. Below a 1.50 m to 2.50 m thick layer of alluvial clay, mostly gravelly sands are located (Fig. 1). The original bank protection measure was riprap (Fig. 2) made from LMB<sub>5/40</sub> armour stones (layer thickness approx. 60 cm to 90 cm). Underneath, a mixture of armour stones and soil can be found down to a depth of 60 cm (BAW, 2010a). At certain points, old pavement still serves as a bank protection measure.

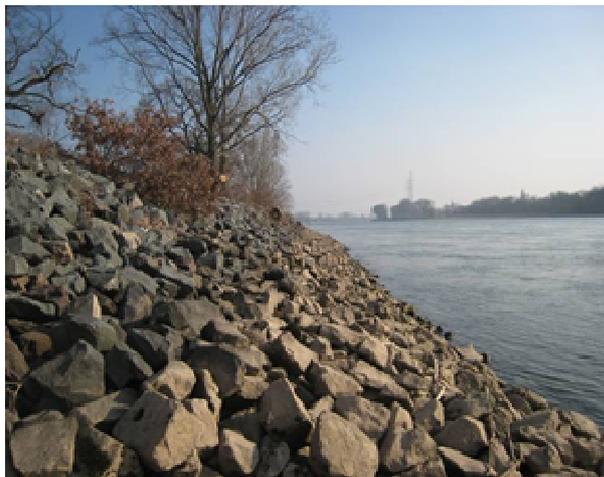
Figure 2: Old riprap revetment; picture taken on 22 February 2011

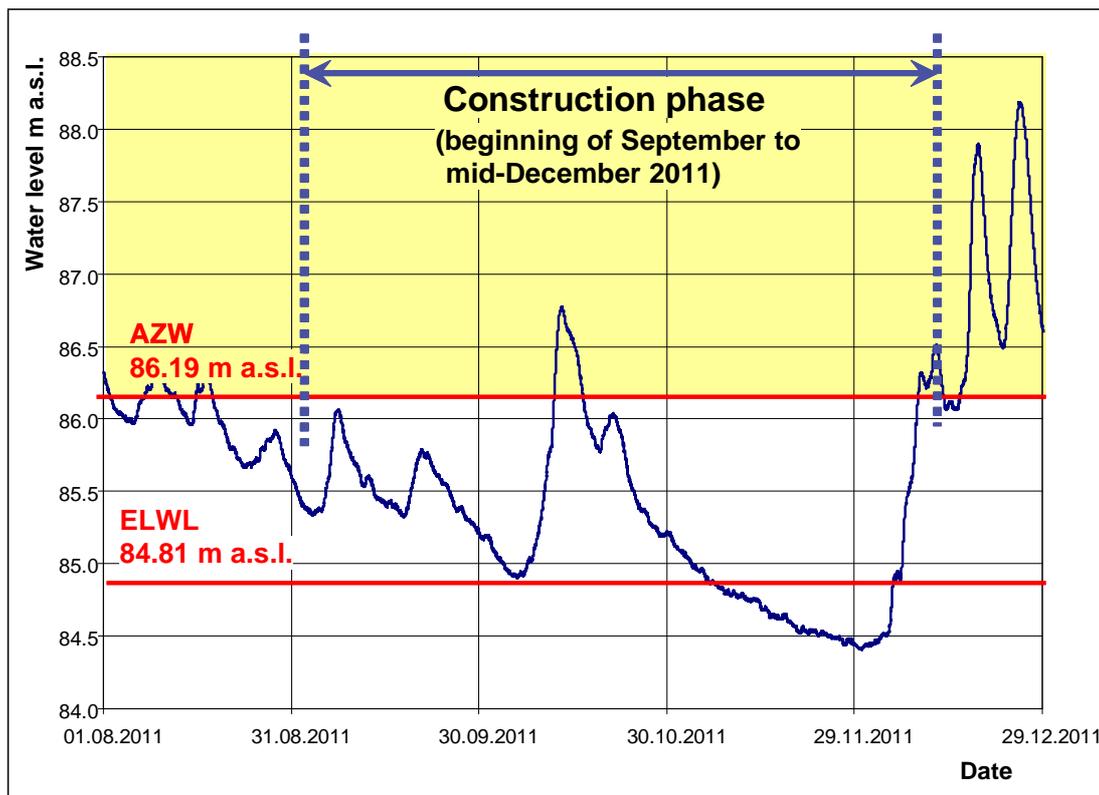
Figure 3: Hydrograph of the River Rhine at the Worms gauge

The technical-biological bank protection measures were installed from September to December 2011. A land-based construction method was chosen. Meteorological and hydrological conditions were good. During the construction phase, the water levels of the Rhine were low (cf. Fig. 3), so that the measures could mostly be installed under dry conditions. The construction works were not interrupted or delayed. A quality check on 14 December 2011 confirmed that the measures were installed properly. The acceptance of the entire construction is scheduled for October 2012 after the first vegetation period. Until then, the construction firm is in charge of the maintenance.

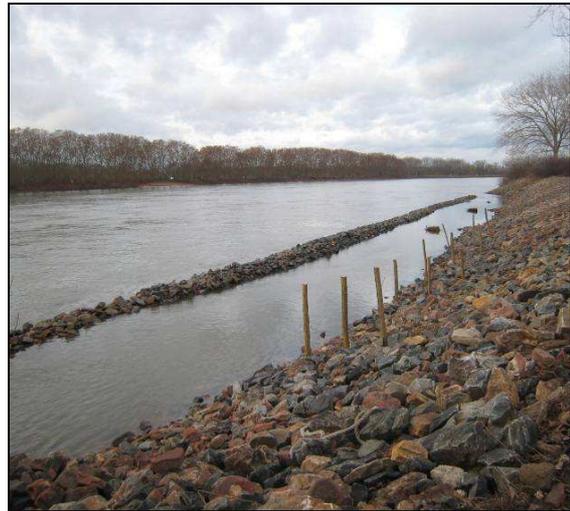
**Ecological objective:**

- Enhance structural diversity and promote flora and fauna
- Promote native woody plants
- Create protected shallow water zone for aquatic fauna
- Promote animals with wood habitats (e.g. birds and insects)

For the ecological improvement of the riprap revetment, materials such as log branch cuttings, brush and hedge layers as well as living fascines (TF1) and methods such as hydroseeding on

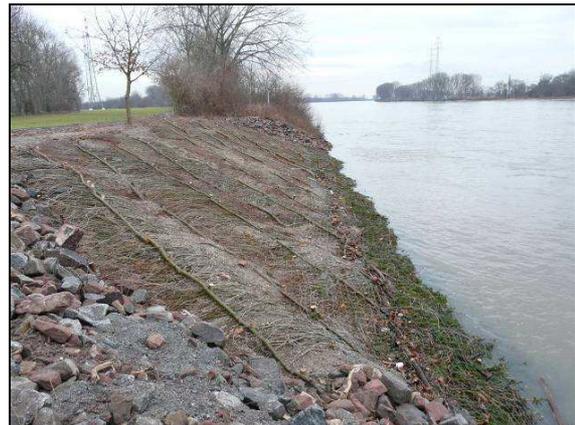
**Test field 2: Removal of riprap, willow brush mattresses with branches orientated diagonally to the direction of flow (Rhine-km 440.820 to 440.860)**

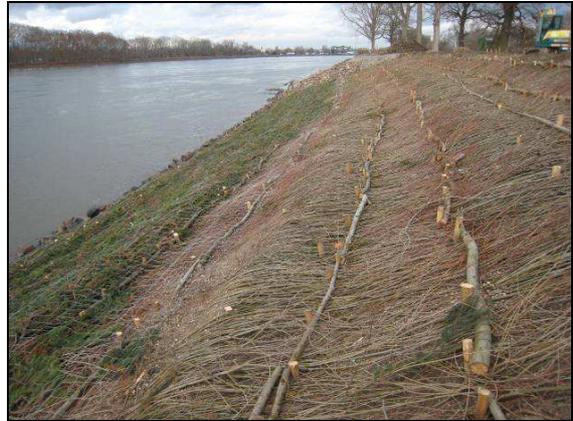
**Test field 3: Removal of riprap, willow brush mattresses with branches orientated transversally to the direction of flow (Rhine-km 440.880 to 440.950)****Bank protection:**

Removal of riprap, spreading out of willow brush mattresses on the bank with branches orientated transversally to the direction of flow of the Rhine

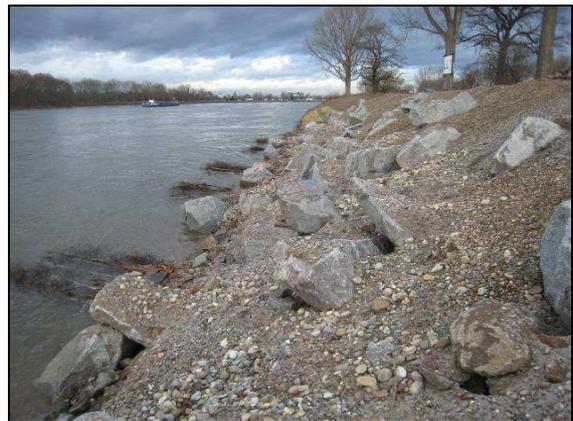
**Test field 4: Riprap with gravel fill, groups of individual stones, dead wood fascines****Bank protection:**

Riprap remains  
Ecological improvement through enhancement of material and structure:

alginate (TF 6) were used. Moreover, the bank structure was enhanced through dead wood fascines and individual stones (TF 4). In these three fields, riprap is still the main protection measure, whereas additional elements were only installed for ecological reasons. Testing these measures is important for waterway sections which are subject to high hydraulic loading and still require a riprap revetment. The assessment of these three improvement measures will focus on the ecological effectiveness.

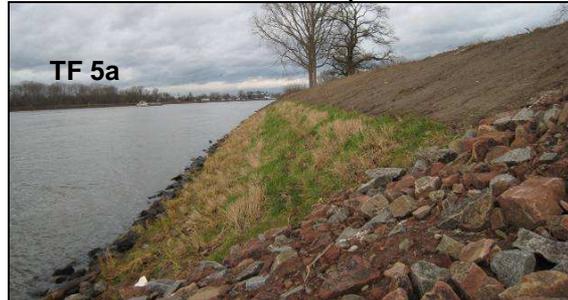
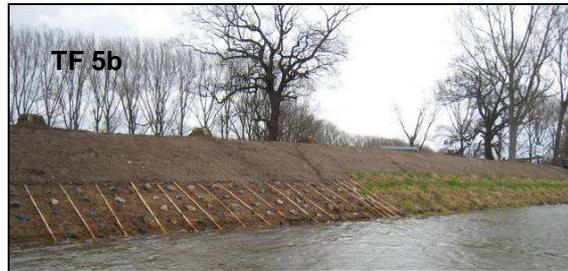
**Test field 5: Removal of riprap, installation of reed gabions, stone mattresses, plant mattresses and hedge layers (Rhine-km 441.000 to 441.110)**

**TF 5b:** Stone mattresses, combined with plant mattresses in lower slope area and covered with soil in upper slope area, hedge layers on upper edge of slope

All measures installed on granular filter

The filter stability of the bank may also cause problems in the initial state. Thus, reed gabions and stone mattresses were installed on top of a granular filter (TF 5) (BAW, 2011a). Different filter mats (TF 7) – sheep wool fleeces, coir mats, geotextile fleeces – were installed under the plant mats, however, none of them could meet all the demands – filter stability, strength, permeability to roots, and if possible, biodegradability. Future experience will show which products are suitable. Since the branch cuttings (TF 2 and 3) were installed as closely together as possible and covered with auxiliary brushwood, no additional filter was installed in these test fields.

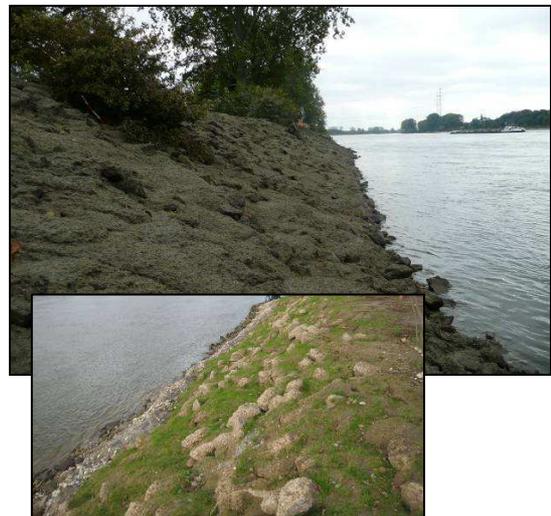
**Test field 6: Riprap with top soil alginate blend, hydroseeding and individual plants (Rhine-km 441.125 to 441.200)**

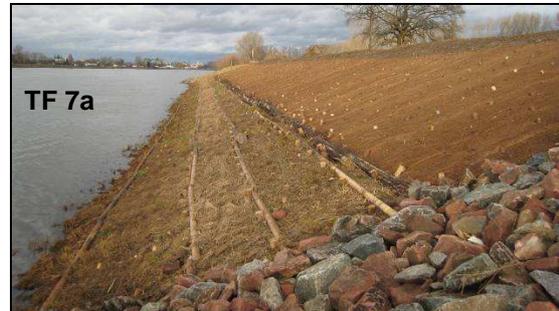
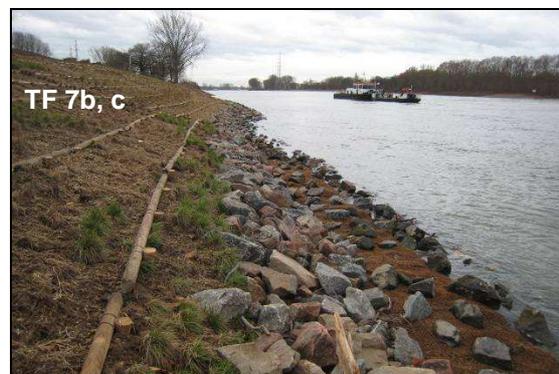
**Test field 7: Removal of riprap, installation of different filter mats (sheep wool fleece, geotextile, coir) and plant mats, dead wood fascines, vegetation rolls, hydroseeding (Rhine-km 441.200 to 441.375)**

**TF 7a:** Reed mats (common reed) in lower and middle slope area on sheep wool fleece (7a1) or geotextile (7a2), dead wood fascines in middle slope area, coir-covered hydroseed in upper slope area

**TF7b and 7c:** Vegetation rolls at AZW (coir (TF7b) or sheep wool (TF7c) envelope), plant mats from AZW +0.5 m to upper edge of slope on geotextile (TF7b) or sheep wool fleece (TF7c) in lower slope area, on coir mat in upper slope area (TF7b and c).

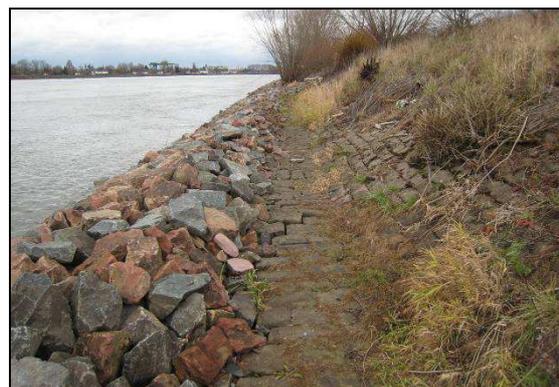
**Test field 8: Riprap and pavement with reeds, elevation of existing stone wall (Rhine-km 441.375 to 441.475)**

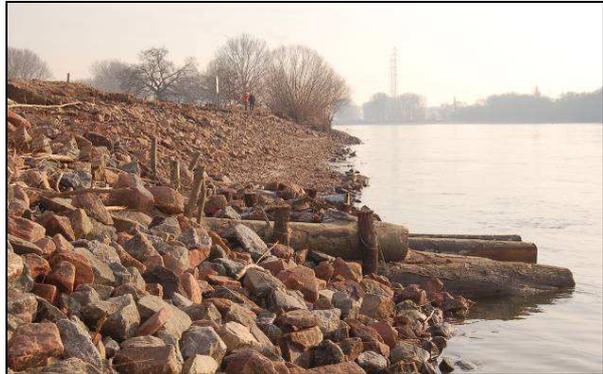
**Test field 9: Removal of riprap, acceptance of free erosion and succession, wooden groyne (tree trunks arranged in the form of a Spanish fan and buried in the slope), log branch cuttings (Rhine-km 441.475 to 441.600)**

In TF 9, the test field with the lowest hydraulic loads, the riprap was removed and not replaced by any new measure, so that free erosion can be assessed. How is the bank changing due to hydraulic loads and flooding? Will conditions stabilize in the long term? A wooden groyne (tree trunks arranged in the form of a Spanish fan and buried in the slope) guarantees a safe transition to the existing revetment behind the end of the test stretch. The maintenance path is to be protected by willow cuttings.
